The Uniform Building Inspection Report

Single Family Residence:
[REDACTED]

Inspection Company:
INSPECT LV
7345 S. Durango Dr. #B107-159
Las Vegas, Nevada 89113
(702) 210-5333

Inspector:
Andrew Aliotti, CPI
IOS.0002659-RES

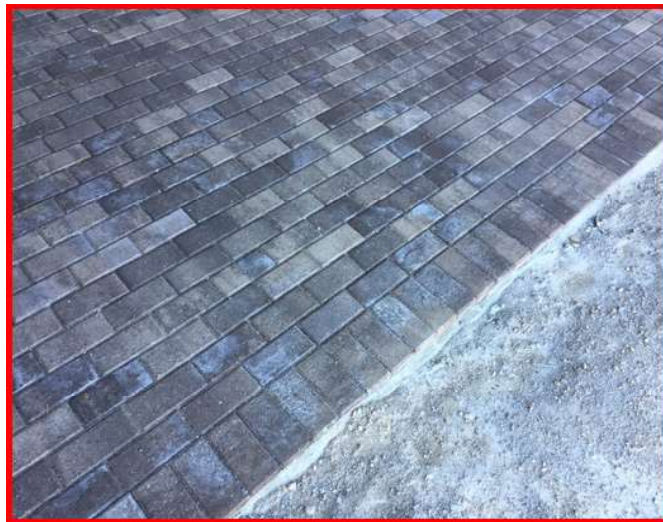
Photo 02-135(1):

VARIOUS LOCATIONS: Efflorescence is a natural occurrence. The potential for efflorescence exists in all Portland cement-based products. Efflorescence is a salt that is left on the surface of concrete upon drying and is generally a cosmetic concern in nature. If the efflorescence is considered unsightly by the homeowner, it can be removed with a brush and water. For more stubborn areas, add a cup of white vinegar to a bucket of water. Efflorescence that is severe, recurring, or accompanied by degradation of the concrete surface may indicate the application of excessive moisture, an elevated concentration of salts in the applied water, numerous cycles of wetting and drying and/or a more substantial presence of salts within the surrounding environment. No action is deemed necessary to address this issue other than to improve component appearance. Monitor the situation on a regular basis. Corrections by a qualified licensed contractor, if and when necessary, are recommended.

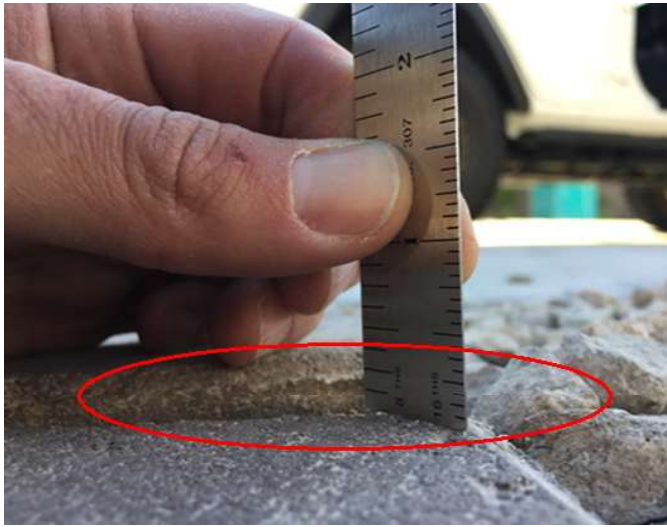
Photo 02-156(1): Driveway

MULTIPLE LOCATIONS: Some settling of the masonry driveway should be expected. However, settling or heaving in excess of a 1/4 inch is unacceptable. It is recommended the builder or responsible prime contractor review this issue and correct as required in order to provide conformance with residential construction performance standards. Any photographs depicted are only representative photographs of this finding.

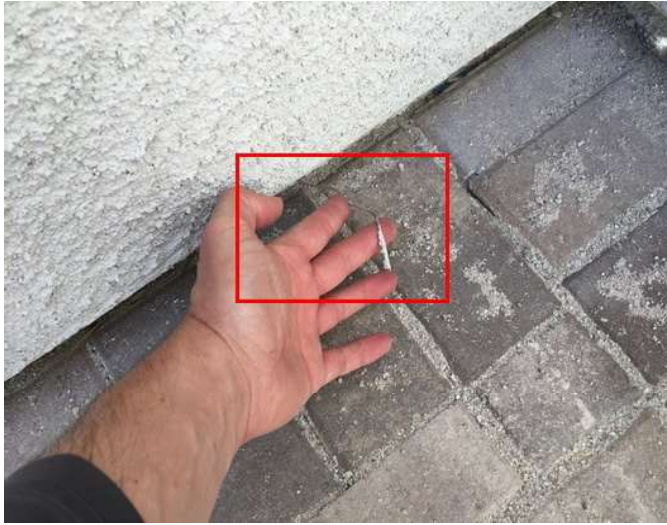
Photo 07-135(1): Courtyard

MULTIPLE LOCATIONS: Nails, screws, wire, garbage and other construction debris were observed on grade in the front and rear yard area in several locations. Refer to the photographs for further clarification. The Nevada Performance Guidelines published by the Southern Nevada Home Builders Association, reviewed and accepted by the Nevada State Contractors Board states that the final grade soil should be free of construction debris to a depth of at least 5 inches. It is recommended the builder or responsible prime contractor review this issue and correct as required in order to provide conformance with residential construction performance standards.

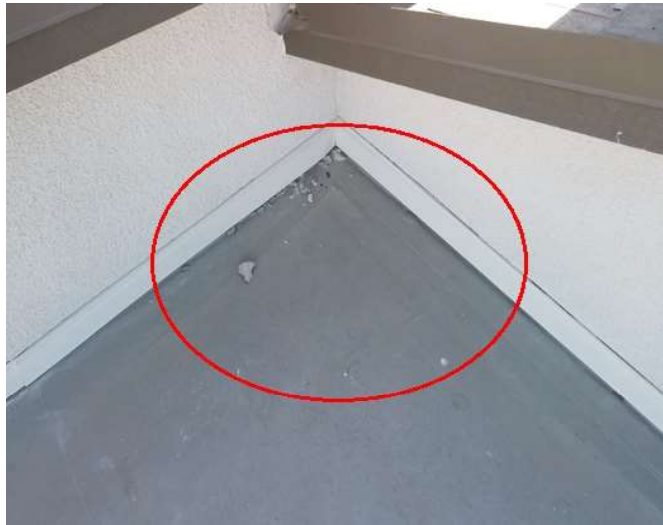
Photo 11-330(1):

COVERED PATIO: Although typical or common for the age of the structure or component, modifications may be in order. It is recommended the builder or responsible prime contractor review this issue and correct as required in order to provide conformance with residential construction performance standards.

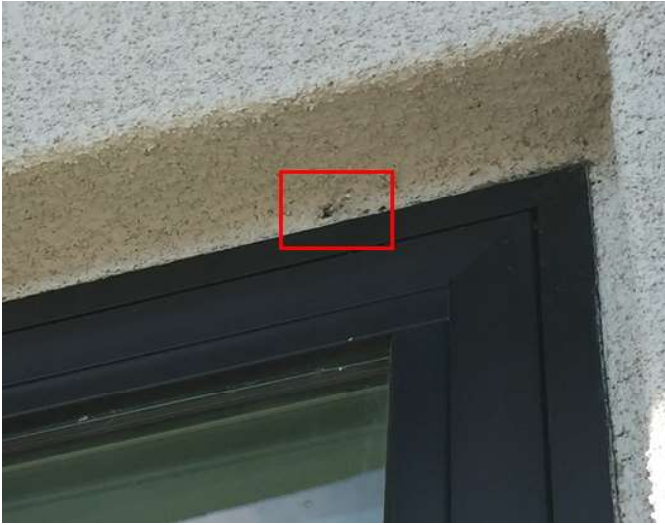
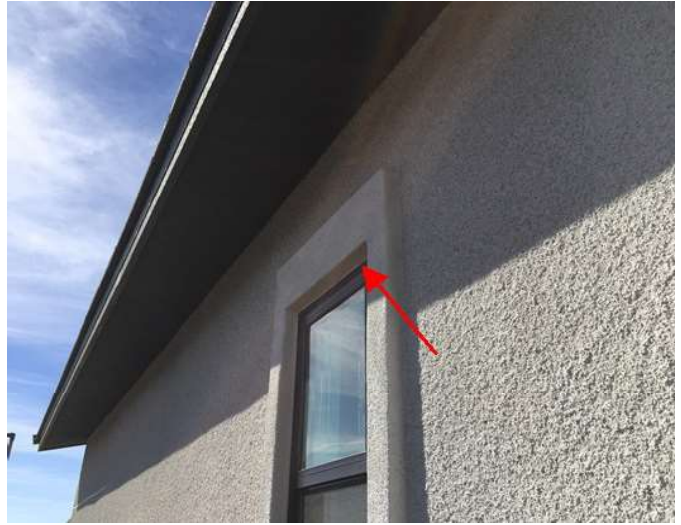
EAST: This finding does not appear to conform to building standards and practices in effect at the time of construction or installation. It is recommended the builder or responsible prime contractor review this issue and correct as required in order to provide conformance with residential construction performance standards. Caution is advised. The finding could be, or could become, hazardous under certain circumstances. Any photographs depicted are only representative photographs of this finding.

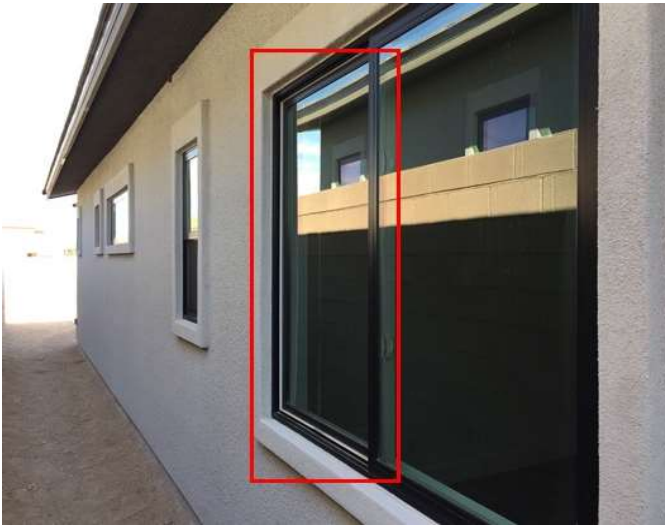
Photo 14-235(1):

14-235: Window screen(s) missing. [F] [R]

WEST BEDROOM: The installation does not appear to be in conformance with manufacturer's guidance or specifications. It is recommended the builder or responsible prime contractor review this issue and correct as required in order to provide conformance with residential construction performance standards.

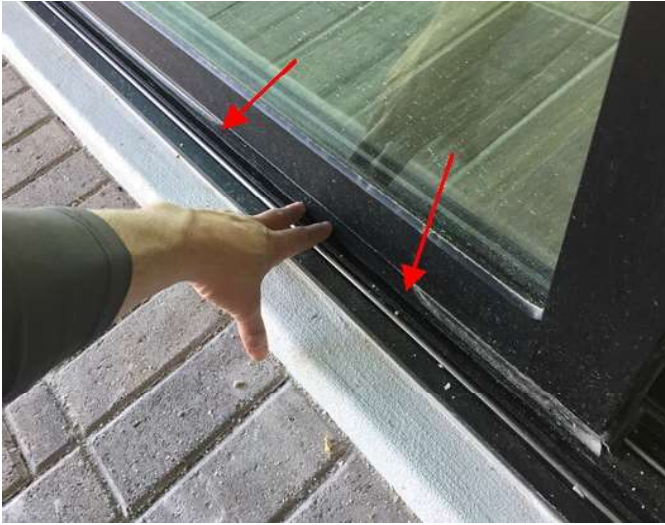
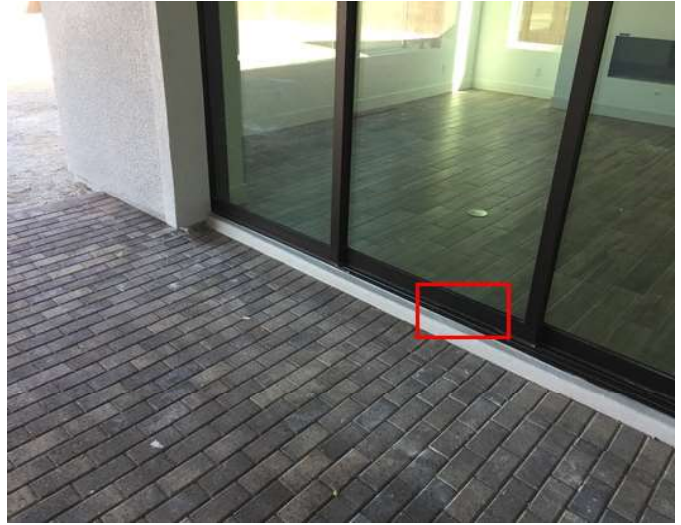
LIVING ROOM: The sweep at the base of the door appeared folded at the depicted section. Discretion advised. The significance of the situation, problem or defect is uncertain. Further study is advised. It is recommended the builder or responsible prime contractor review this issue and correct as required in order to provide conformance with residential construction performance standards.

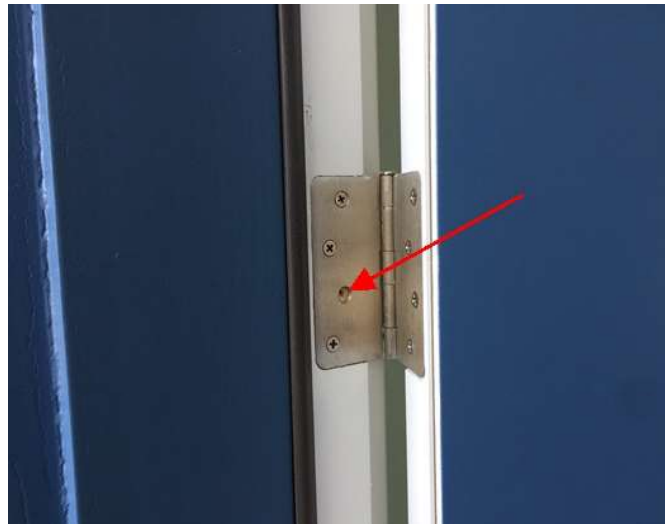
Photo 15-295(1):

15-295: Hinge screw(s) missing. [F] [R]

FRONT DOOR: When hinge kits are provided to the builder or installing contractor the kit usually contains all 1/2 screws. The installer is suppose to omit one of the 1/2 inch screws and install a 3 inch screw on the casing side of the hinge to pull the hinge into the king stud (2X4) and provide full support. The installer correctly omitted the 1/2 inch screw but did not install the 3 inch screw. This is the most important fastener of the hinge. The installation does not appear to be in conformance with manufacturer's guidance or specifications. It is recommended the builder or responsible prime contractor review this issue and correct as required in order to provide conformance with residential construction performance standards.

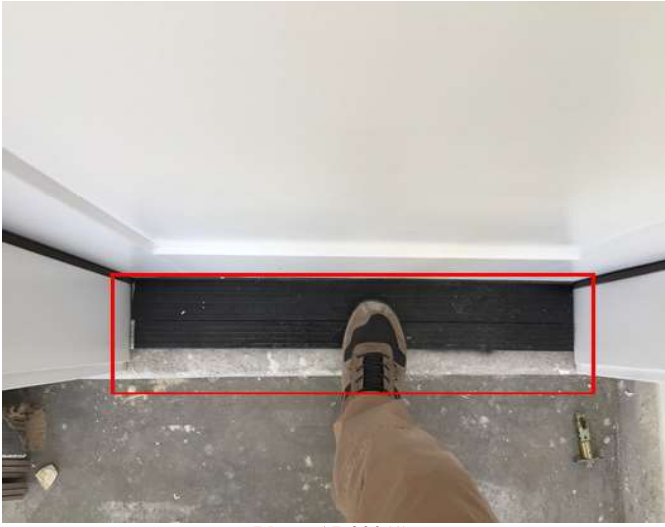
Photo 15-300(1):

15-300: Threshold improperly supported. [N] [R]

GARAGE: Movement noted when traversed. No shims or caulking was observed. The installation does not appear to be in conformance with manufacturer's guidance or specifications. It is recommended the builder or responsible prime contractor review this issue and correct as required in order to provide conformance with residential construction performance standards.

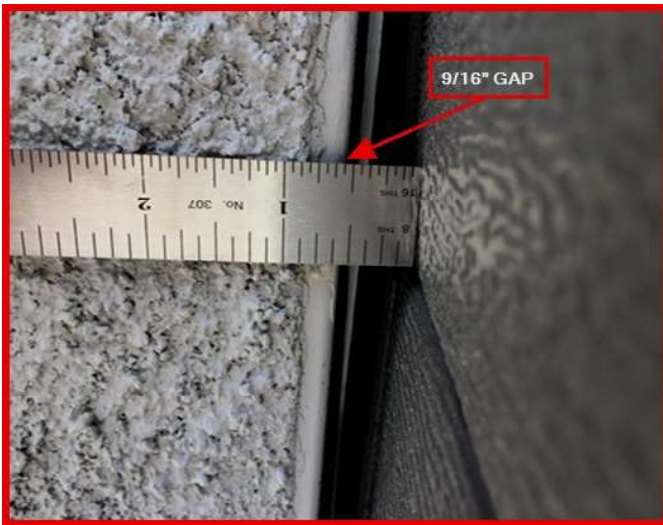
Photo 16-110(1): 2-car garage

GARAGES: Overhead garage doors should be installed per the manufacturer installation instructions and create a seal with the garage floor at the time of the walkthrough. 1/2 inch gaps at the sides and top are the maximum acceptable measurement between the structure and the garage door. It is recommended the builder or responsible prime contractor review this issue and correct as required in order to provide conformance with residential construction performance standards. Any photographs depicted are only representative photographs of this finding.

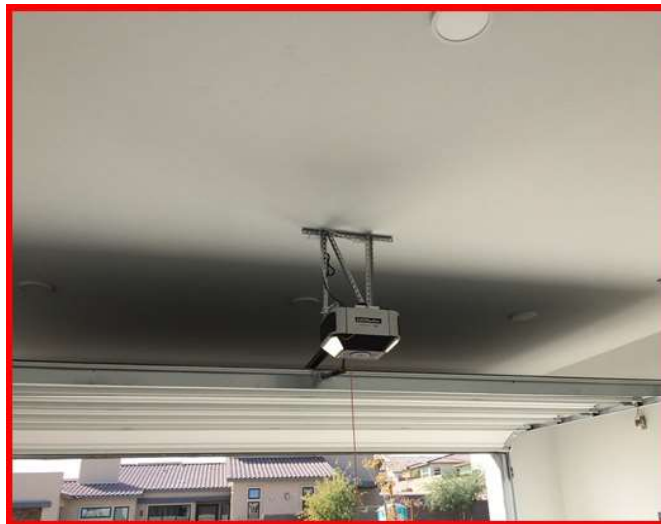
Photo 16-230(1):

16-230: Garage door pressure / tension reverse failed to actuate. [R] [C]

2-CAR GARAGE: The overhead door motor would not reverse when upward pressure was applied during the closing cycle. It is a simple but critical adjustment that needs to occur. The guidance is generally contained in the garage door opener homeowners manual or can be obtained on the internet. Failure of a system or component. The system or component fails to operate or to operate properly. Correction or modification decreases the probability of excessive deterioration. If this initial path of resolution fails to provide desired results it is recommended this finding and all associated components be reviewed and corrected as needed by a licensed and qualified Overhead Door Contractor.

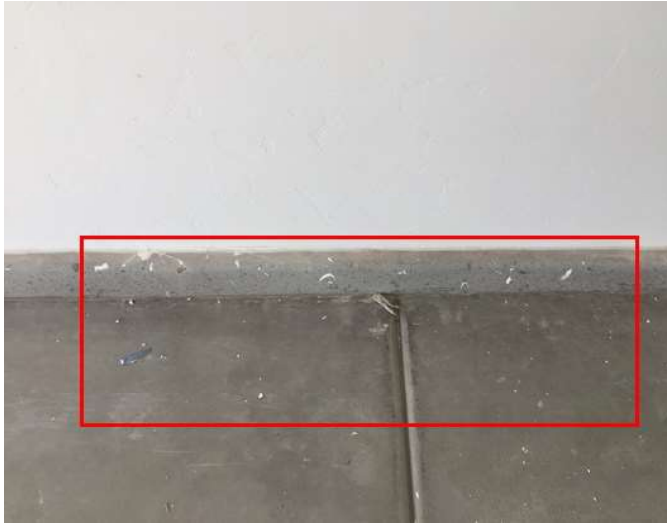
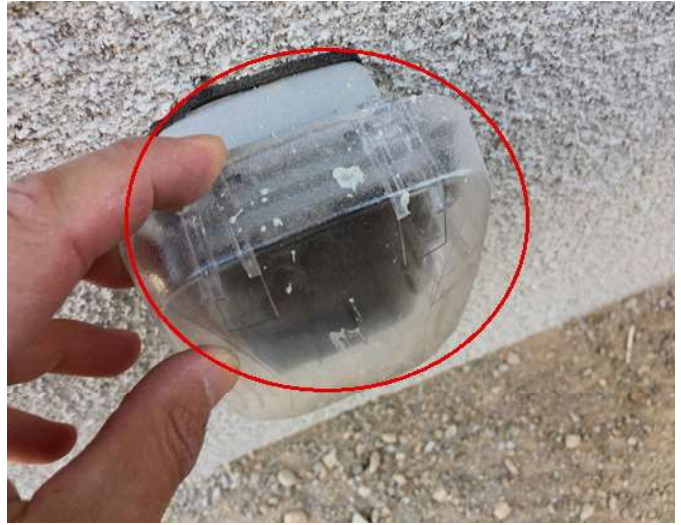
17-120: Paint, stains, damage and building material noted on surfaces not intended. [R] [B]

MULTIPLE LOCATIONS: Refer to the photographs for further clarification. The photographs depicted are only representative photographs of this finding. It is recommended the builder or responsible prime contractor review this issue and correct as required in order to provide conformance with residential construction performance standards. This finding does not appear to conform to building standards and practices in effect at the time of construction or installation. The client is reminded that this is not a punch list inspection. It is a general review of the overall property condition. There are many more sub-standard locations than what it depicted in this report. It is highly advised that the Superintendent do a critical walkthrough of the property and have all repairs accomplished in conformance with current building standards and practices.

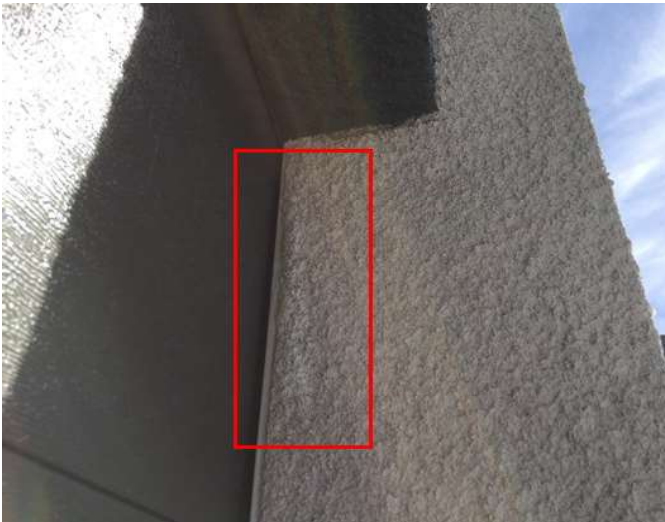
Photo 17-125(1): South

17-125: Paint observed not in conformance with performance standards. [B] [R]

MULTIPLE LOCATIONS: The industry standard for painting is outlined in the RS Means Residential and Light Construction Standards manual. The standard, PDCA P5-94, 5.6 delineates a "properly painted surface" as: One that is uniform appearance, color and sheen. It's one that is free from foreign material, lumps, skins, runs, sags, holidays, misses, strike through, or insufficient coverage. It's a surface which is free of drips, splatters, spills, or overspray which were caused by the contractors' work force. Compliance to meeting the criteria of a "properly painted surface" shall be determined when viewed without magnification at a distance of five feet or more under normal lighting conditions and from a normal viewing position. Normal lighting conditions are described as those in place when the project is finished. This includes but is not limited to design lighting (e.g. wall washers, spots and floods, etc) and natural lighting (e.g. skylights, clear view windows, window walls, and window treatments, etc). PDCA Standard P1.92.2.4 states, "The contractor will produce a properly painted surface." Refer to the photographs for further clarification. It is recommended the builder or responsible prime contractor review this issue and correct as required in order to provide conformance with residential construction performance standards.

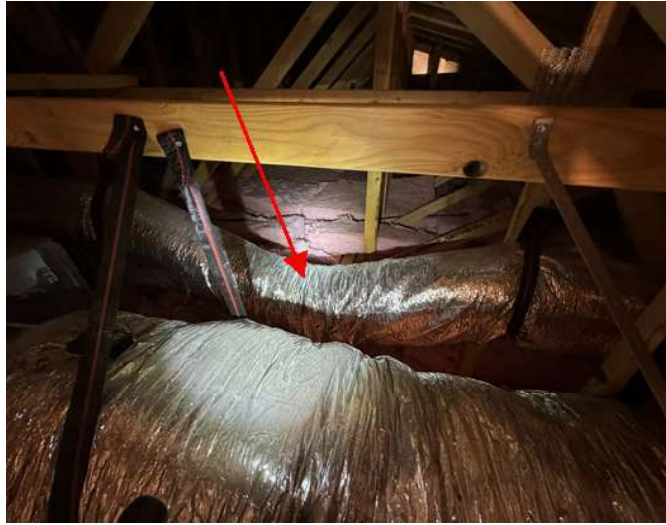
Photo 22-125(1):

ATTIC: Supports should be installed at least once every four (4) feet. The maximum allowable flexible duct sag between supports is one-half inch (1/2") per foot. Refer to the photographs for further clarification. This finding does not appear to conform to building standards and practices in effect at the time of construction or installation. It is recommended the builder or responsible prime contractor review this issue and correct as required in order to provide conformance with residential construction performance standards. Any photographs depicted are only representative photographs of this finding.

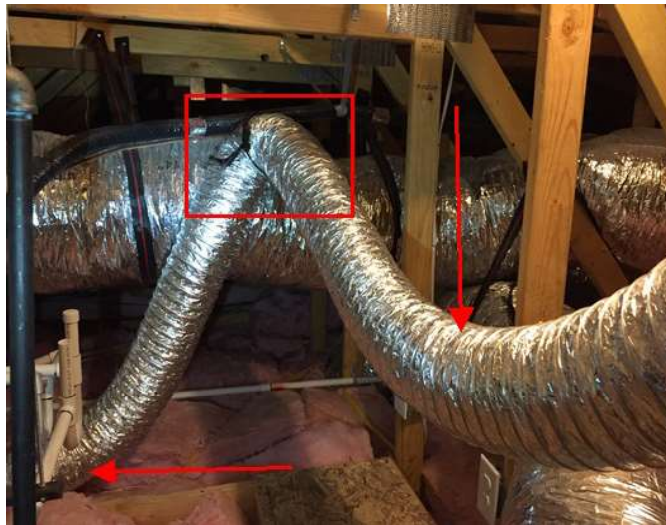
Photo 22-141(1):

ATTIC: Flexible duct should be installed without kinks or sharp bends, which restrict airflow. All bends should be gradual with the radius of each bend not exceeding the diameter of the flex duct. The duct also did not appear properly supported. The installation does not appear to be in conformance with manufacturer's guidance or specifications. It is recommended the builder or responsible prime contractor review this issue and correct as required in order to provide conformance with residential construction performance standards.

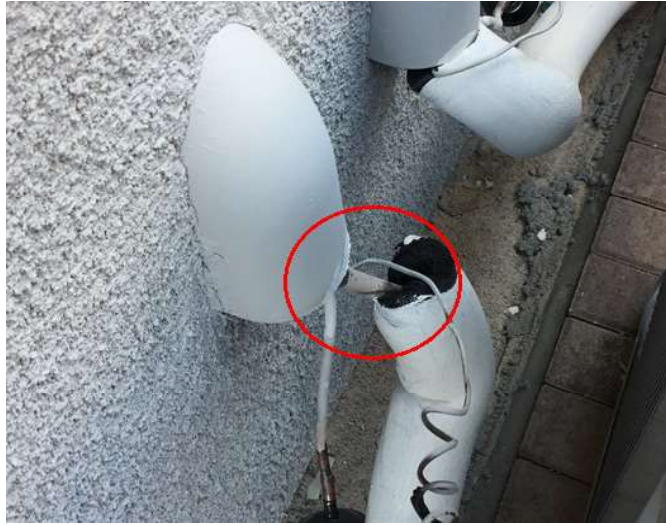
Photo 23-115(1):

23-115: Refrigerant line insulation missing. [E] [P]

WEST: Section of foam pipe insulation missing on the refrigerant line. This may result in a measurable efficiency degradation. Fully wrapping the insulation and wall flashing with a 20 mil PVC tape can reduce the frequency of this recurring preventive maintenance issue. Painting the PVC tape (the type and color of paint is of no significance) to protect the tape from exposure to the sun will greatly reduce the frequency of this recurring maintenance issue. The appropriate maintenance should be performed to restore the component to proper condition. Correction of this issue usually results in an increase of efficiency. Correction or modification decreases the probability of excessive deterioration.

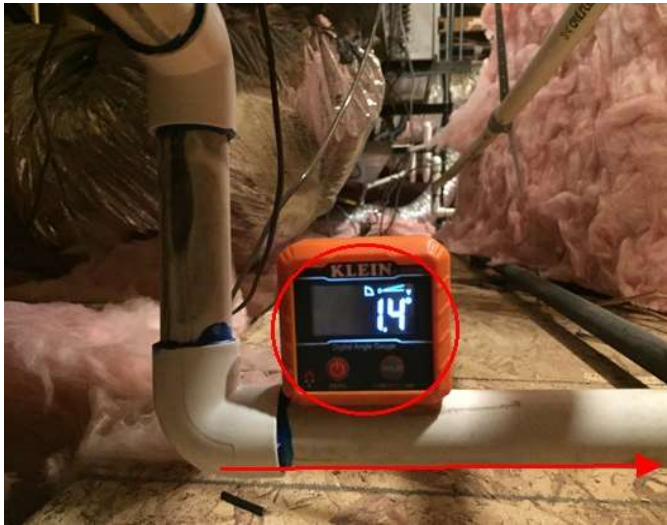
Photo 23-165(1):

23-165: Condensate drain improper. [R] [F]

ATTIC: Noted at the North system. The secondary line appeared to run uphill. The installation does not appear to be in conformance with manufacturer's guidance or specifications. It is recommended the builder or responsible prime contractor review this issue and correct as required in order to provide conformance with residential construction performance standards.

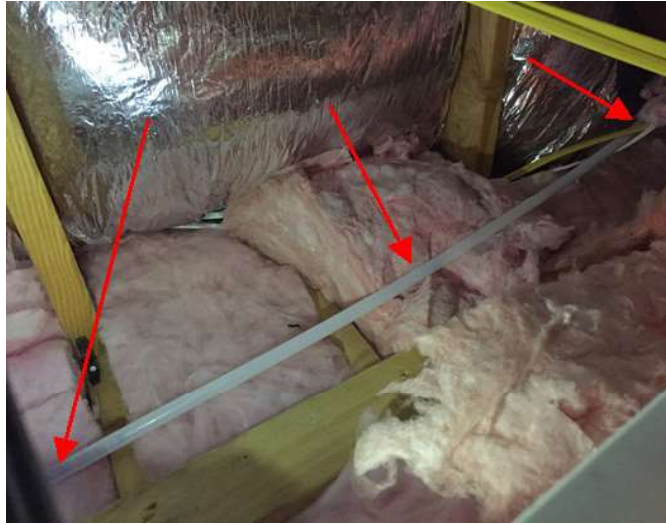
Photo 42-145(1):

Plastic water pipe in the attic was noted to be above the interior insulation envelope in several area and not insulated. This condition may result in excessive water usage in the summer with the home owner being required to run the water for an extended period of time before cold water may be obtained. In the colder months the pipes are exposed to potential freeze. National building standards require all piping to be protected from freeze. This finding does not appear to conform to building standards and practices in effect at the time of construction or installation. It is recommended the builder or responsible prime contractor review this issue and correct as required in order to provide conformance with residential construction performance standards.

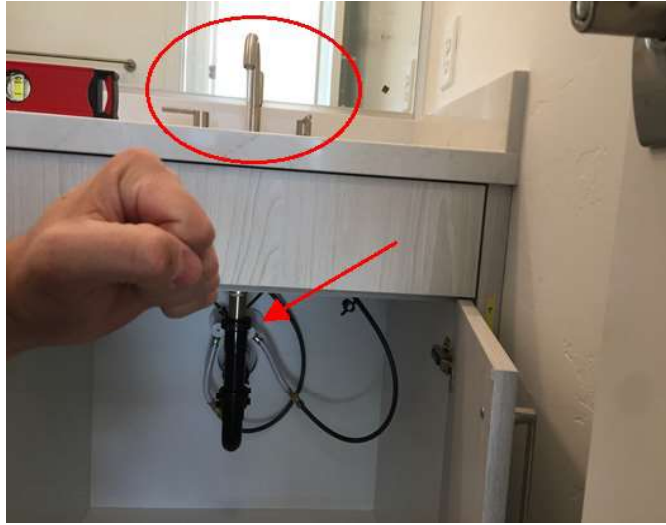
Photo 42-255(1):

42-255: Water-hammer or pipe rattle noted. [R] [F]

ALL BATHROOMS: Loud clunking or banging noises known as “water hammer” should not occur with normal use of the system. Notify the contractor of water hammer. Contractor should correct as necessary during the warranty period. Correction of water hammering may include adjustment of pressure regulator or the use of arrestor device. Due to the velocity of the flow of water, its weight, waste debris it may be carrying, and its varying temperature that causes pipes to expand and contract, the water system may emit audible noises. A “ticking” sound in drain line pipes is common due to expansion or contraction of the pipes as warmer or cooler water is run through the pipes. The Contractor is not responsible for sounds caused by homeowner’s installation of new fixtures or other plumbing system devices. It is recommended the builder or responsible prime contractor review this issue and correct as required in order to provide conformance with residential construction performance standards.

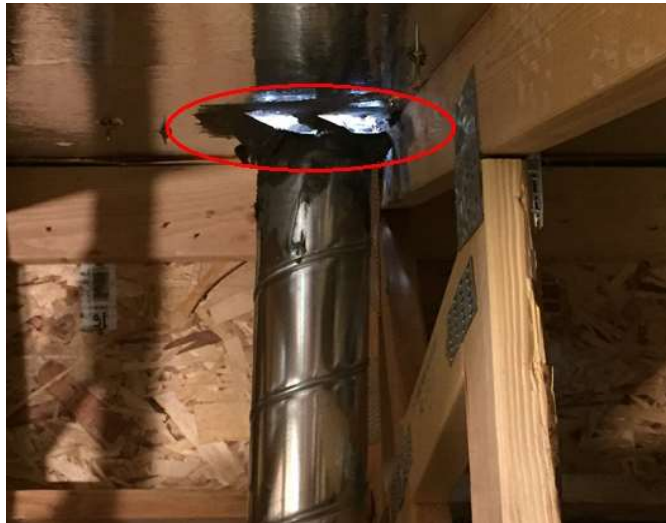
Photo 45-075(1):

ATTIC: What appeared to be the dryer vent was gapped at the roof deck. The appropriate maintenance should be performed to restore the component to proper condition or replace if necessary. It is recommended the builder or responsible prime contractor review this issue and correct as required in order to provide conformance with residential construction performance standards.

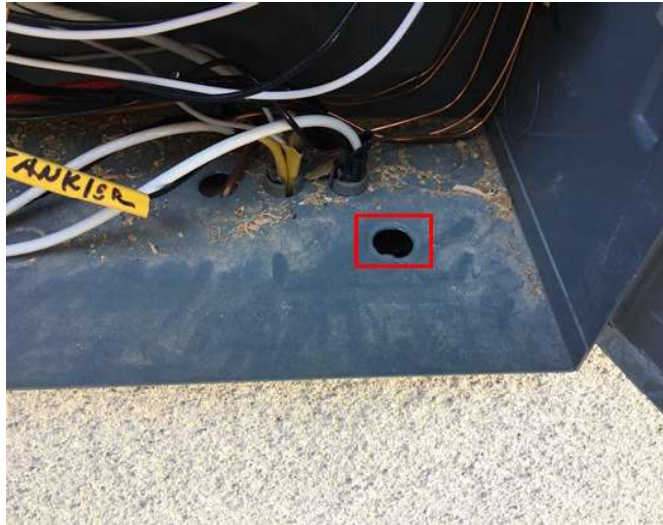
Photo 52-240(1):

52-240: Conduit knock out seal(s) missing from main panel. [B] [R]

The appropriate maintenance should be performed to restore the component to proper condition. It is recommended the builder or responsible prime contractor review this issue and correct as required in order to provide conformance with residential construction performance standards.

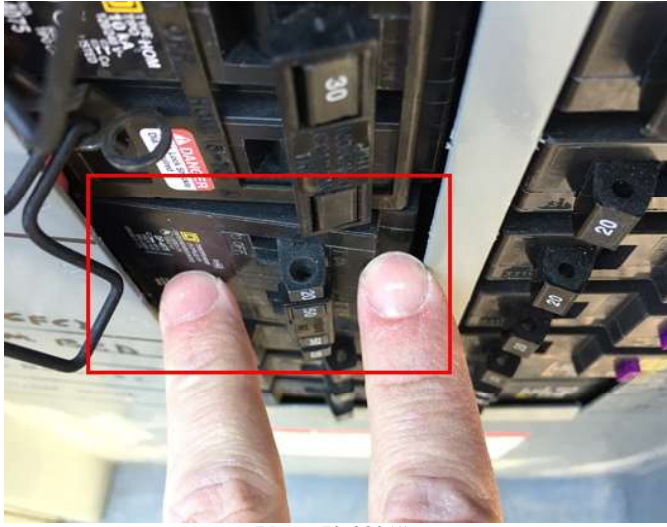
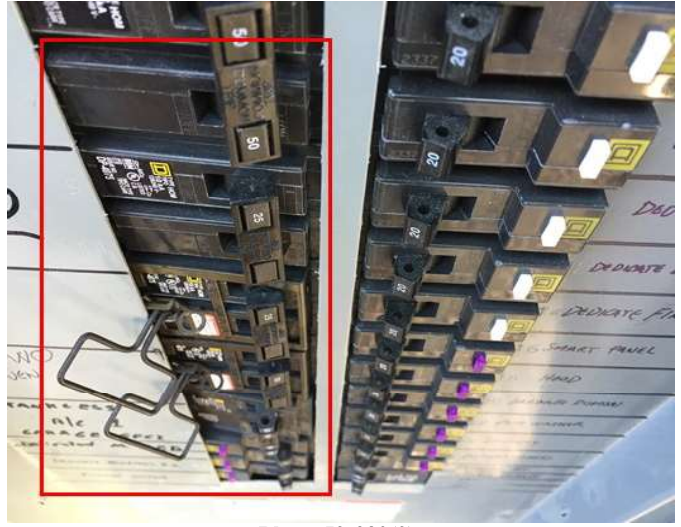
MAIN PANEL: The depicted breaker did not appear to be properly installed. This may be due to the improper fitment of the deadfront cover. Discretion advised. The significance of the situation, problem or defect is uncertain. Further study is advised. It is recommended the builder or responsible prime contractor review this issue and correct as required in order to provide conformance with residential construction performance standards. This finding could be, or could become hazardous under certain circumstances.

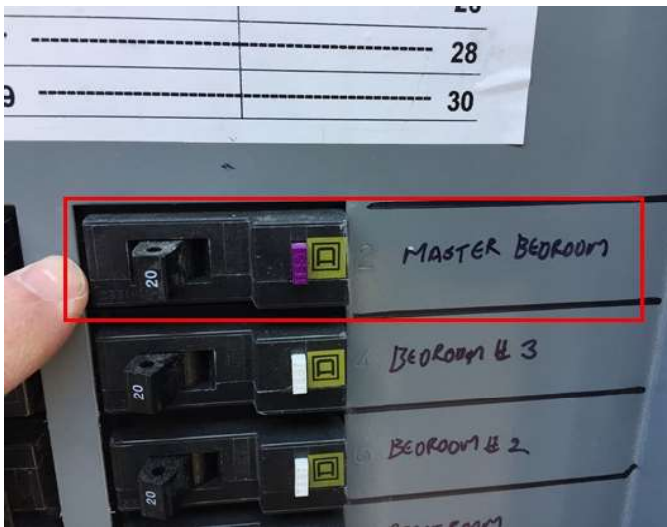
Photo 52-390(1): Main panel

52-390: Electrical breaker found in open / off position. [N] [R]

MULTIPLE LOCATIONS: The depicted breakers were found in the open/off position. A circuit found in the off position may be that way due to an unsafe condition or a repair in progress. Standard practice is to leave it off and document the finding. It is recommended the builder or responsible prime contractor review this issue and correct as required in order to provide conformance with residential construction performance standards. Discretion advised. The significance of the finding is uncertain. Further study is advised.

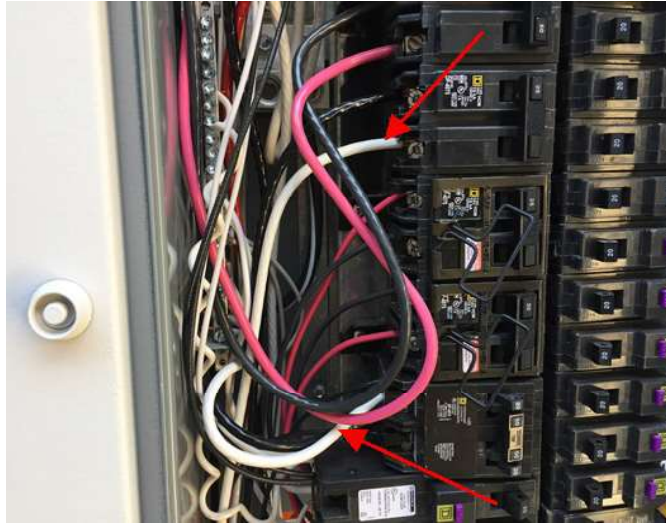
Photo 52-410(1):

MAIN PANEL: Recommend wrapping the conductor(s) with black electrical tape or coloring with black permanent marker. This should be done at both ends of the run. This finding does not appear to conform to building standards and practices in effect at the time of construction or installation. It is recommended this finding and all associated components be reviewed and corrected as needed by a licensed and qualified Electrical Contractor. Any photographs depicted are only representative photographs of this finding.

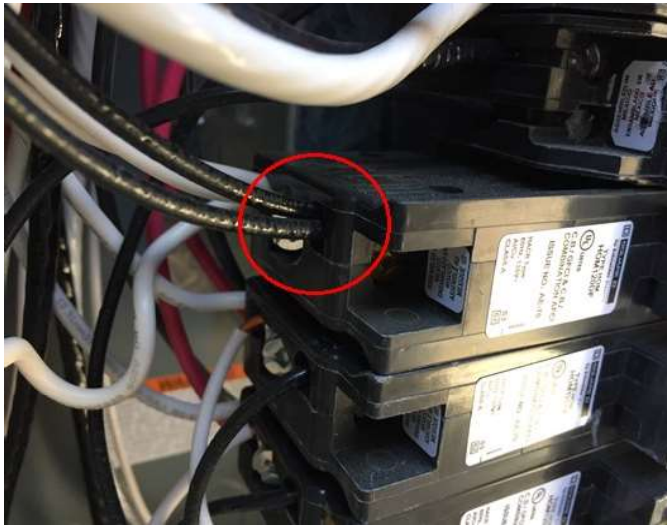
Photo 52-510(1):

52-510: Double stab observed at breaker. [B] [R]

MAIN PANEL: This finding did not appear to meet building standards and practices in effect at the time of construction or installation. It is recommended the builder or responsible prime contractor review this issue and correct as required in order to provide conformance with residential construction performance standards.

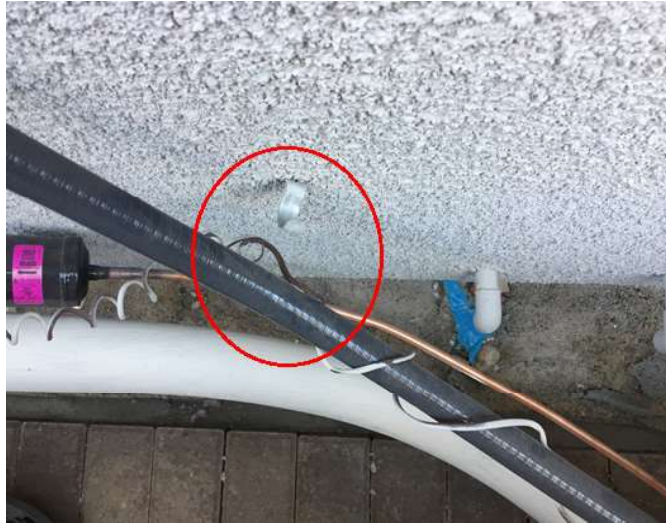
Photo 53-260(1):

WEST: Non-metallic Liquid-tight at 3 ton condenser unit was not clamped to structure. It is recommended the builder or responsible prime contractor review this issue and correct as required in order to provide conformance with residential construction performance standards.

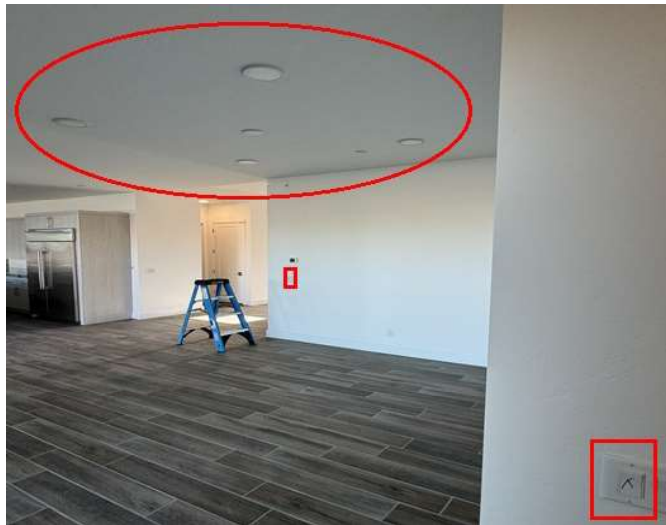
Photo 54-270(1):

54-270: 3-way or 4-way switch inoperative (fails to control from each location). [N] [R]

DINING ROOM: If one switch is in the "off" position the other switch in the circuit becomes inoperable. This is generally an indication that a two-way switch has been installed in a three or four way circuit. Discretion advised. The significance of the finding is uncertain. Further study is advised. It is recommended the builder or responsible prime contractor review this issue and correct as required in order to provide conformance with residential construction performance standards.

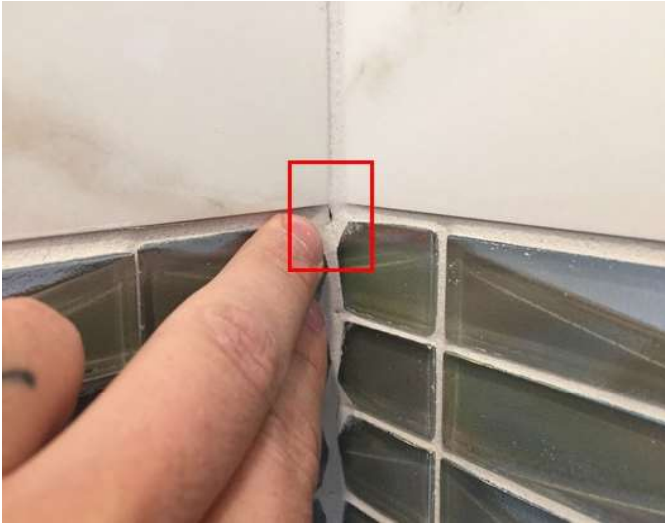
Photo 61-330(1):

S/E BED ENSUITE: Grout voids noted. Left uncorrected, this condition can result in accelerated deterioration, and conditions conducive to the growth and establishment of mold or mildew. It is recommended the builder or responsible prime contractor review this issue and correct as required in order to provide conformance with residential construction performance standards.

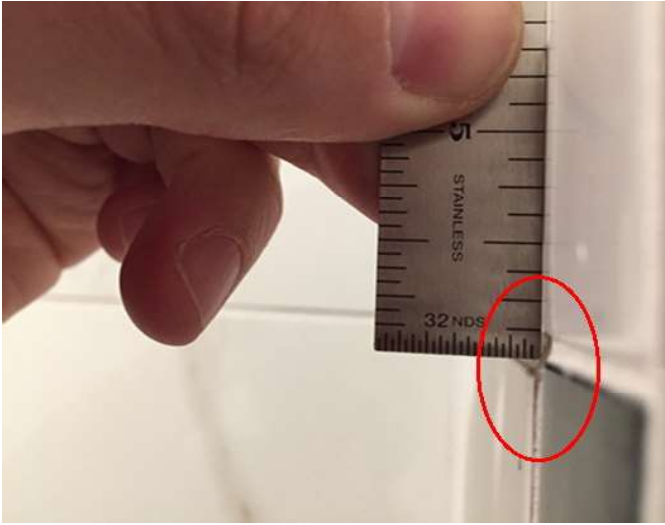
Photo 61-341(1): Hall bathroom

MULTIPLE LOCATIONS: Tile surface should be straight and reasonably flat allowing for individual characteristics of the tile (i.e., Mexican Saltillo tile). Tile should not exceed the manufacturer's recommendations or 1/16 inch lippage in absence of manufacturer's recommendations. Report any uneven or out of line tile to the contractor. Contractor should make necessary repairs during the warranty period. Inherent characteristics of the tile dictate the installation of tile. It is recommended the builder or responsible prime contractor review this issue and correct as required in order to provide conformance with residential construction performance standards.

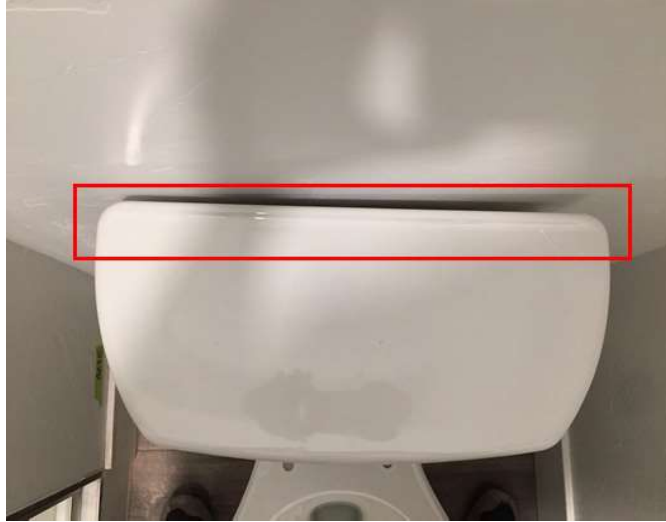
Photo 62-160(1):

HALL BATH: The installation does not appear to be in conformance with manufacturer's guidance or specifications. It is recommended the builder or responsible prime contractor review this issue and correct as required in order to provide conformance with residential construction performance standards.

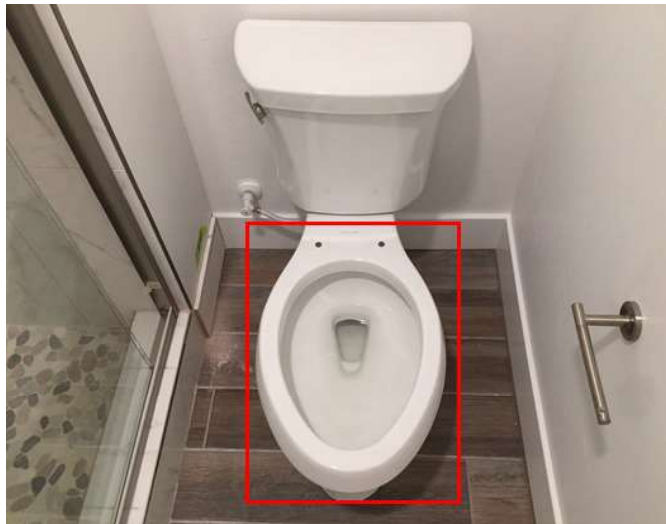
Photo 62-165(1):

62-165: Toilet seat missing. [R] [F]

ALL BATHROOMS: The installation does not appear to be in conformance with manufacturer's guidance or specifications. It is recommended the builder or responsible prime contractor review this issue and correct as required in order to provide conformance with residential construction performance standards.

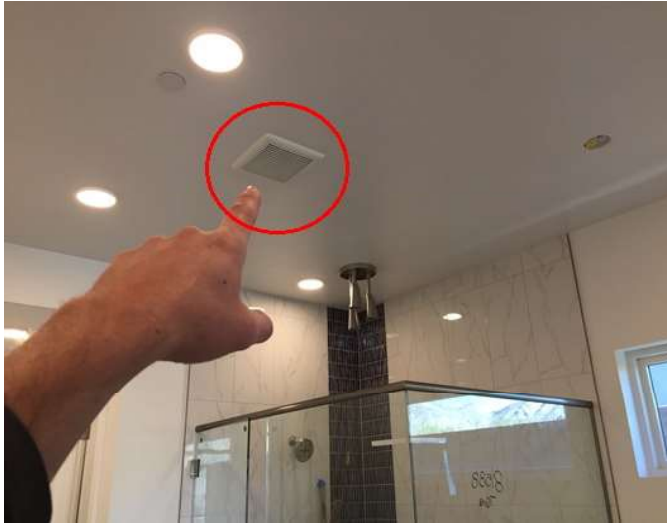
Photo 65-105(1):

MAIN BATH: The appropriate maintenance should be performed to restore the component to proper condition or replace if necessary. Failure of a system or component. The system or component fails to operate or to operate properly. It is recommended the builder or responsible prime contractor review this issue and correct as required in order to provide conformance with residential construction performance standards.

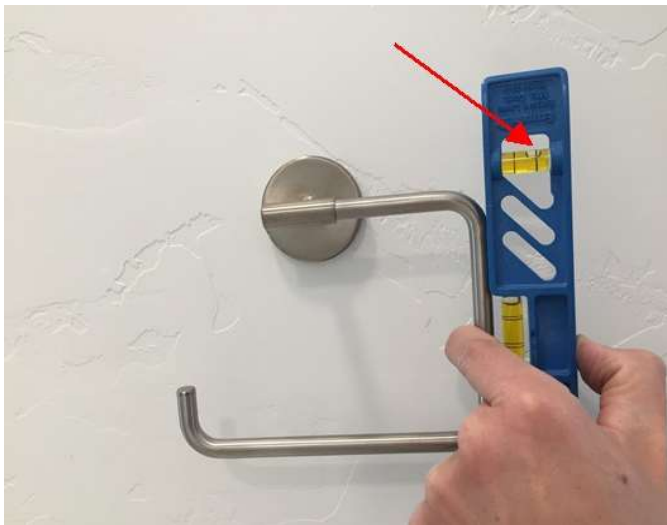
Photo 68-130(1):

MULTIPLE LOCATIONS: Most hand towel holders and toilet paper holders were not installed level. The installation does not appear to be in conformance with manufacturer's guidance or specifications. It is recommended the builder or responsible prime contractor review this issue and correct as required in order to provide conformance with residential construction performance standards.

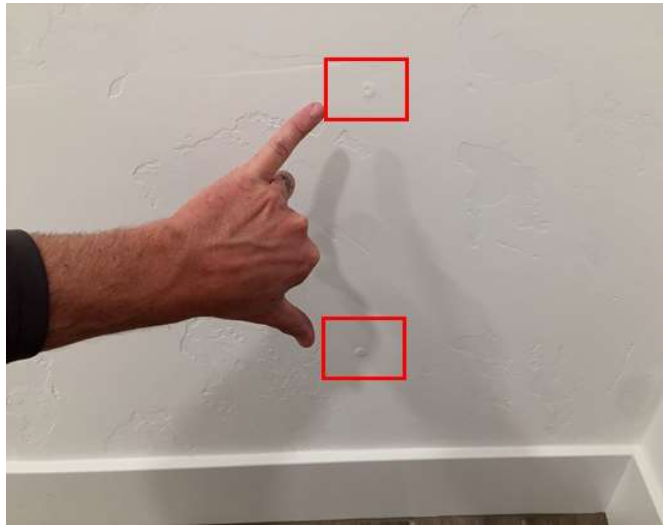
Photo 71-170(1):

MAIN BED CLOSET: The Nevada State Contractors Board performance guideline manual states "nail-pops" to be unacceptable. This finding does not appear to conform to building standards and practices in effect at the time of construction or installation. It is recommended the builder or responsible prime contractor review this issue and correct as required in order to provide conformance with residential construction performance standards.

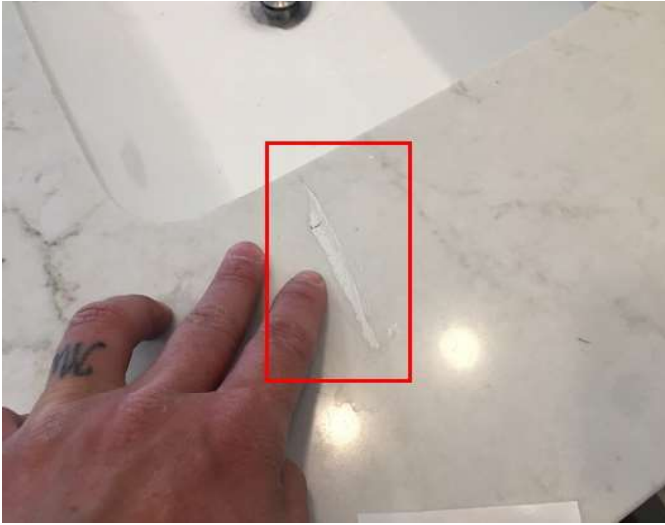
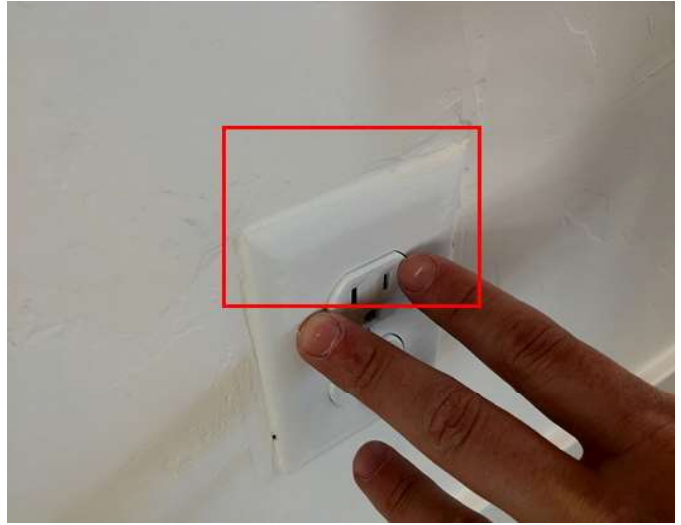
71-430: Paint noted on surfaces not intended to be painted. [R] [B]

MULTIPLE LOCATIONS: Refer to the photographs for further clarification. The photographs depicted are only representative photographs of this finding. It is recommended the builder or responsible prime contractor review this issue and correct as required in order to provide conformance with residential construction performance standards. This finding does not appear to conform to building standards and practices in effect at the time of construction or installation.

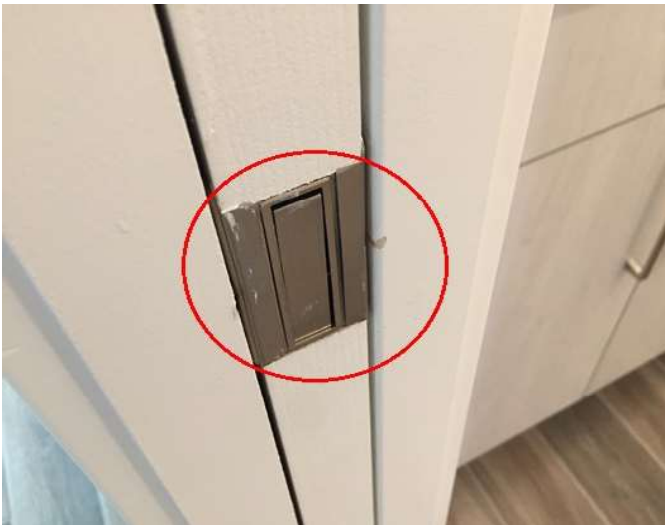
Photo 71-435(1): Laundry

MULTIPLE LOCATIONS: The Industry Standard for painting is outlined in the RS Means Residential and Light Construction Standards manual. The standard, PDCA P5-94, 5.6 delineates a "properly painted surface" as: One that is uniform appearance, color and sheen. It's one that is free from foreign material, lumps, skins, runs, sags, holidays, misses, strike through, or insufficient coverage. It's a surface which is free of drips, splatters, spills, or overspray which were caused by the contractors' workforce. Compliance to meeting the criteria of a "properly painted surface" shall be determined when viewed without magnification at a distance of five feet or more under normal lighting conditions and from a normal viewing position. Normal lighting conditions are described as those in place when the project is finished. This includes but is not limited to design lighting (e.g. wall washers, spots and floods, etc) and natural lighting (e.g. skylights, clear view windows, window walls, and window treatments, etc). PDCA Standard P1.92.2.4 states, "The contractor will produce a "properly painted surface." Numerous areas of the interior of this structure do not meet the aforementioned minimum performance standard guidelines. It is recommended the builder or responsible prime contractor review this issue and correct as required in order to provide conformance with residential construction performance standards. The photographs depicted are only representative photographs of this finding.

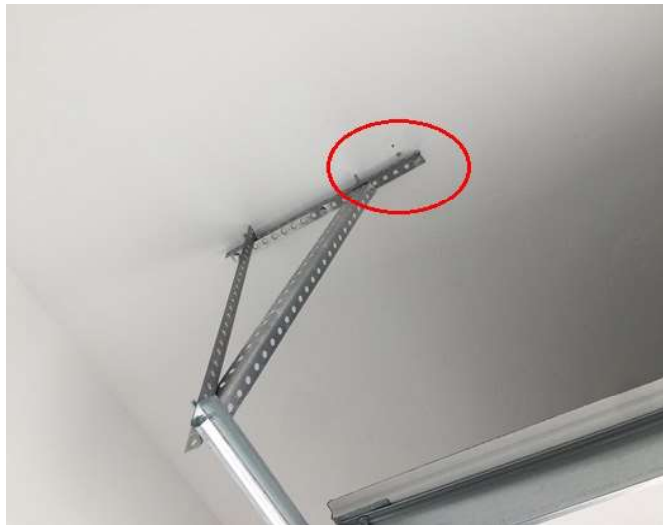
Photo 71-475(1):

2-CAR GARAGE: The ceiling and walls are required to provide fire separation. The appropriate maintenance should be performed to restore the components to proper condition. Caution is advised. The finding could be, or could become, hazardous under certain circumstances. It is recommended the builder or responsible prime contractor review this issue and correct as required in order to provide conformance with residential construction performance standards.

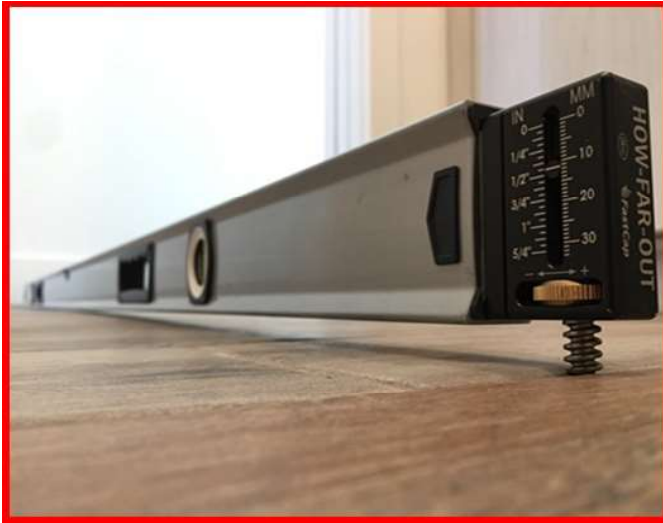
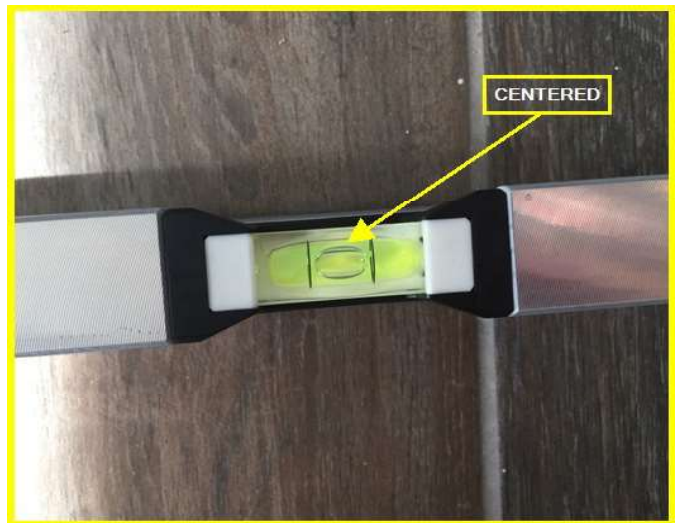
MULTIPLE LOCATIONS: Unevenness of floors or ceilings should not exceed 1/8 inch in 4 feet and should be level within 1/4 inch in 10 feet. High spots can be felt when traversed. This finding does not appear to conform to building standards and practices in effect at the time of construction or installation. It is recommended the builder or responsible prime contractor review this issue and correct as required in order to provide conformance with residential construction performance standards. The photographs depicted are only representative photographs of this finding.

Photo 72-105(1): Laundry- 7/16" out

Photo 72-105(3): S/W bed- 9/16" out

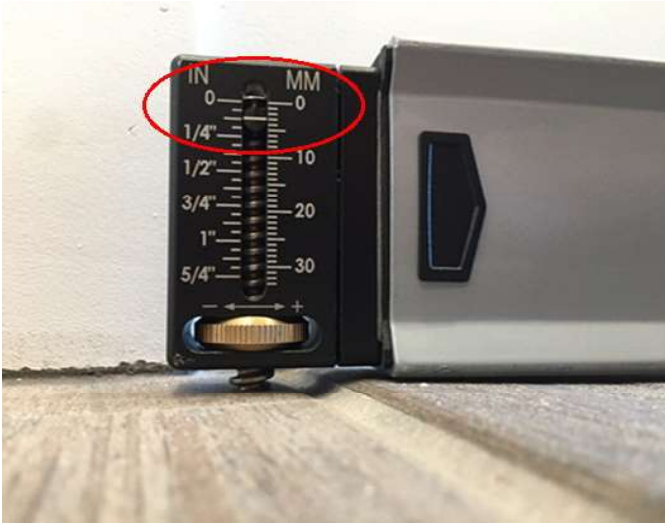
Photo 72-219(1):

MAIN BATHROOM: The Nevada State Contractors Board residential construction performance guideline manual states the tile should be reasonably straight and flat allowing for individual characteristics of the tile. The tile should not exceed the manufacturers recommendation or 1/16" lippage in the absence of manufacturers recommendations. It is recommended the builder or responsible prime contractor review this issue and correct as required in order to provide conformance with residential construction performance standards.
