The Uniform Building Inspection Report

Single Family Residence:
[REDACTED]

Inspection Company:
INSPECT LV
7345 S. Durango Dr. #B107-159
Las Vegas, Nevada 89113
(702) 210-5333

Inspector:
Andrew Aliotti, CPI
IOS.0002659-RES

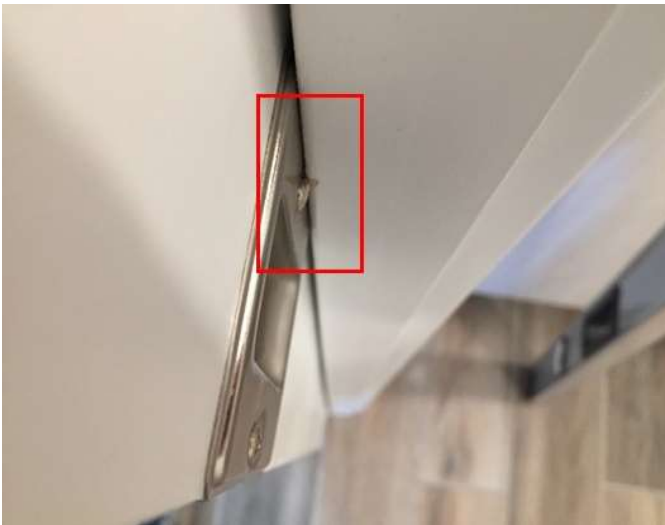
Photo 73-340(1):

LAUNDRY ROOM: Pocket door would contact jamb during operation. The pull was also jammed. The installation does not appear to be in conformance with manufacturer's guidance or specifications. Failure of a system or component. The system or component fails to operate or to operate properly. It is recommended the builder or responsible prime contractor review this issue and correct as required in order to provide conformance with residential construction performance standards.

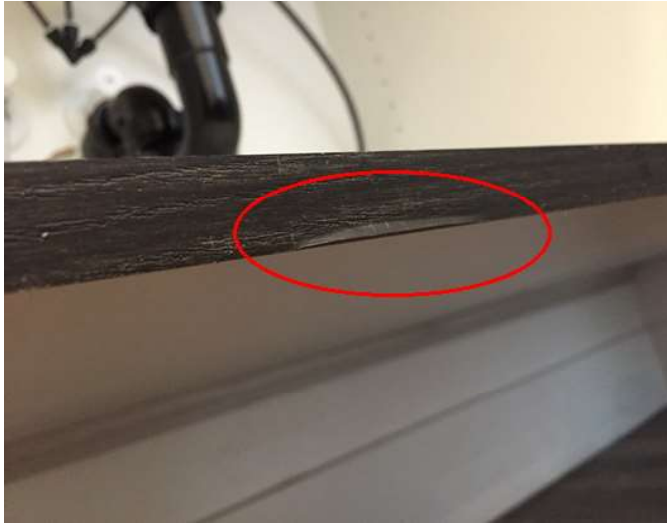
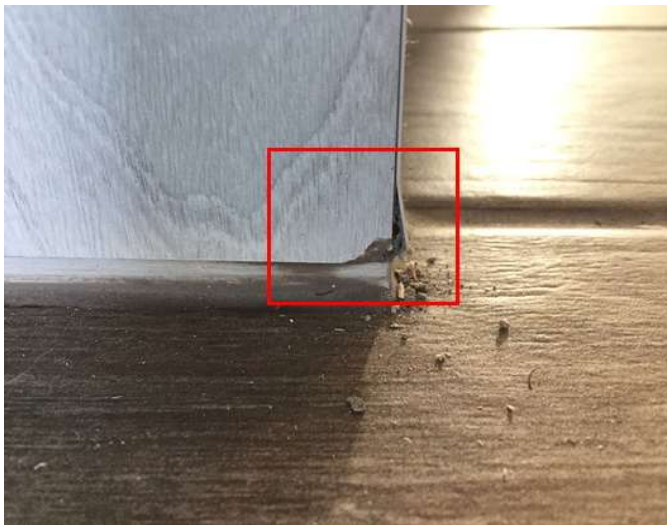
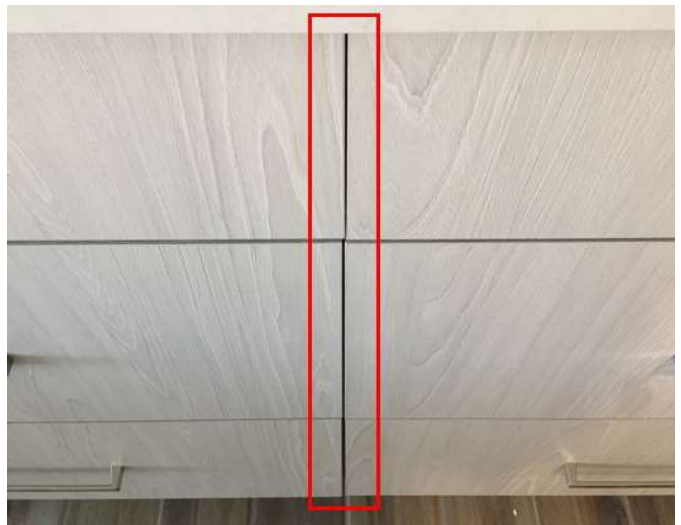
MULTIPLE LOCATIONS: The cabinetry was reviewed for proper alignment. Gaps between matched door or drawer edges that exceed parallel alignment by more than 1/8 inch in 30 inches or the uniformity of any door or drawer edge to any other that exceeds 1/8 inch are not acceptable as delineated by the Residential Construction Performance Guidelines Manual promulgated by the Nevada State Contractors Board. Cabinet and vanity doors, drawers, and other operating parts should function properly. A warped door or drawer up to 1/8 inch in 30 inches may be considered acceptable. Mouldings should fit securely and be level and plumb. All joints should fit within a 1/16 of an inch or less unless otherwise specified and be securely attached. Splices should meet a minimum of 8 lineal feet to all edges. The cabinet/vanity surface finish should not wear off under normal use during the warranty period. It is recommended the builder or responsible prime contractor review this issue and correct as required in order to provide conformance with residential construction performance standards. This finding does not appear to conform to building standards and practices in effect at the time of construction or installation. The photographs depicted are only representative photographs of this finding.

Photo 76-360(11): Kitchen- damage at fridge enclosure
