The Uniform Building Inspection Report - Condensed

Single Family Residence:

123 New Build Ave, Las Vegas, Nevada 89166

0223240900MDH

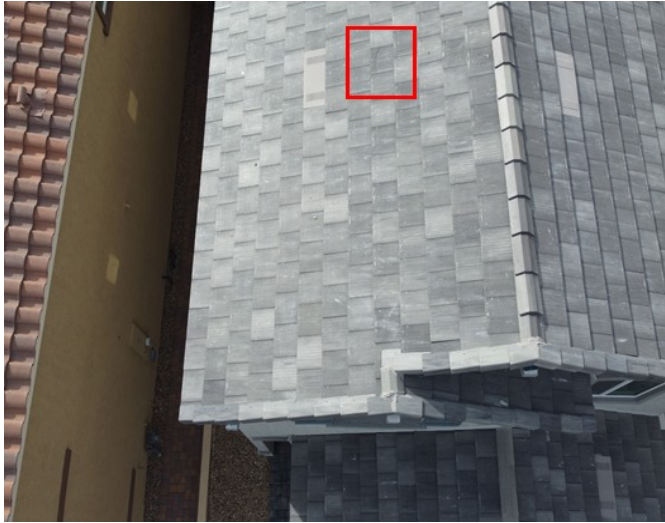
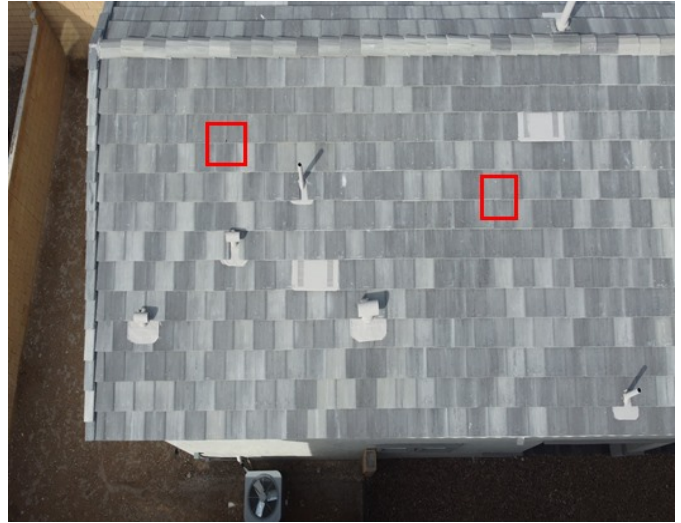
11-220: Roof tiles chipped. [B] [R]

ROOF: Roofing material should be free of cracks, chips or breaks at the time of the homeowner walkthrough. Chips larger than a 1/2 inch are unacceptable. Notify the contractor of any cracked, chipped or broken roofing. Contractor should replace affected tiles during the warranty period. Contractor should repair and/or replace any damaged material promptly. Contractor will make all reasonable efforts to match existing materials as closely as possible; however, the contractor does not guarantee an exact match of either texture or color. Roofing contractors may not be held responsible for damage caused by others. It is recommended the builder or responsible prime contractor review this issue and correct as required in order to provide conformance with residential construction performance standards. Any photographs depicted are only representative photographs of this finding.

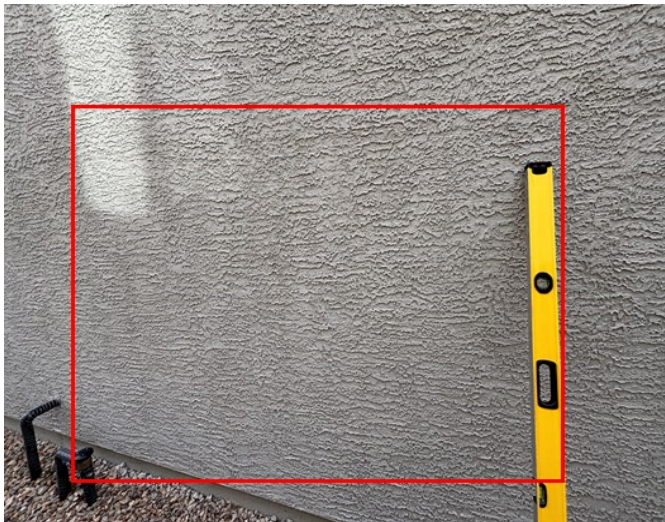
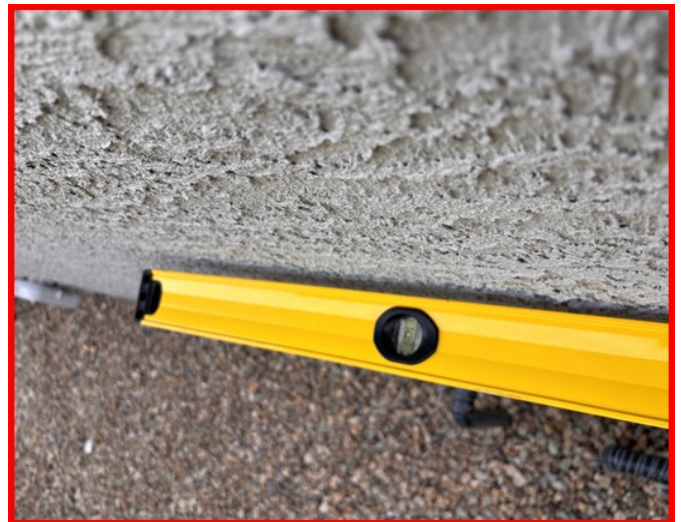
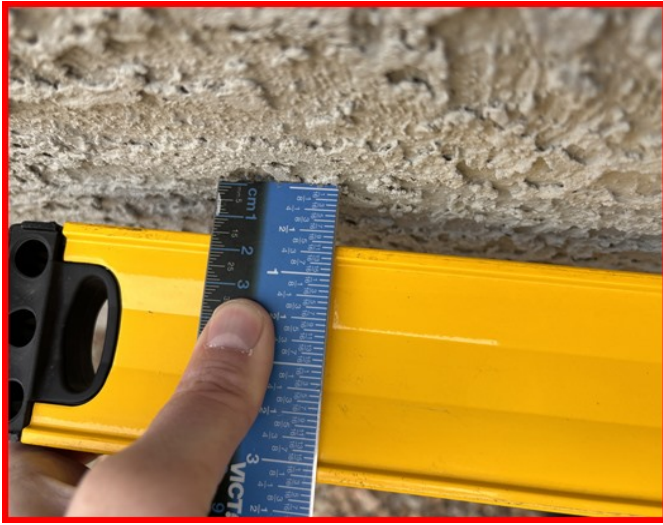
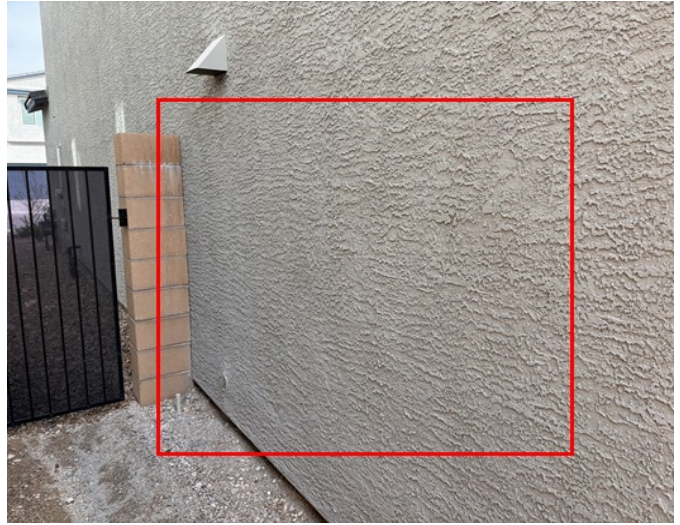
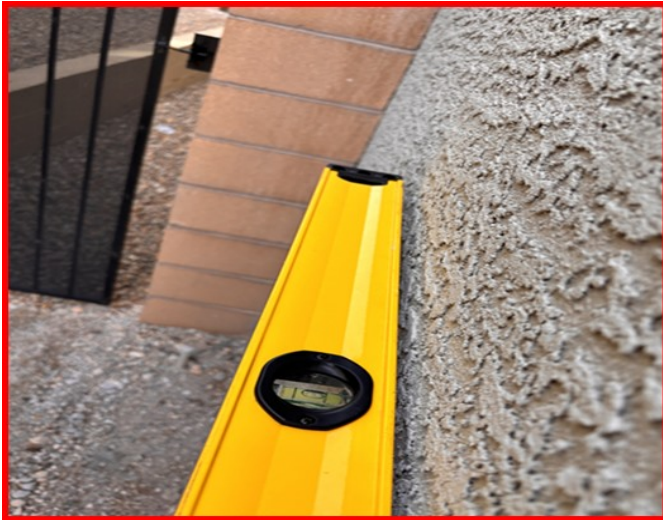
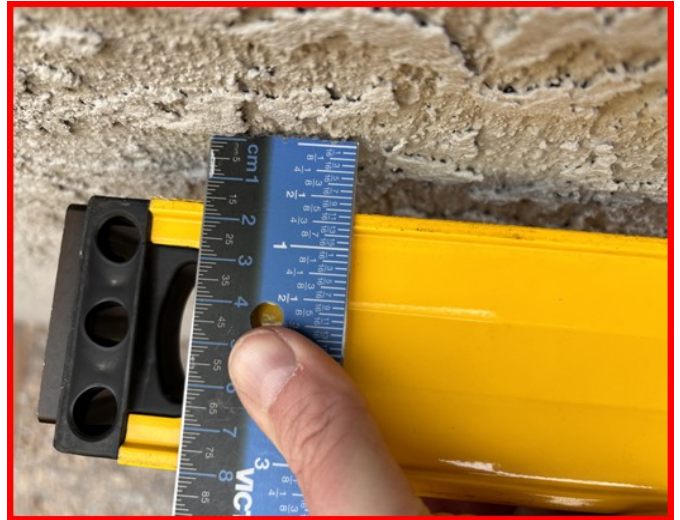
13-130: Stucco siding uneven / not uniform. [B] [R]

EAST SIDE NEAR PVB AND GATE : Stucco should be straight and true within 1/4 inch in 10 feet. Visually, this means that any eye-catching out of plane areas should not occur. Stucco shall be applied with sufficient material and pressure to ensure proper coverage. Holidays, shiners, hollows or voids greater than 1/8" are unacceptable. All corners whether squared or mitered should be clean and tight in base screeds, casing beads or control joints. This finding does not appear to conform to building standards and practices in effect at the time of construction or installation. It is recommended the builder or responsible prime contractor review this issue and correct as required in order to provide conformance with residential construction performance standards. Any photographs depicted are only representative photographs of this finding.

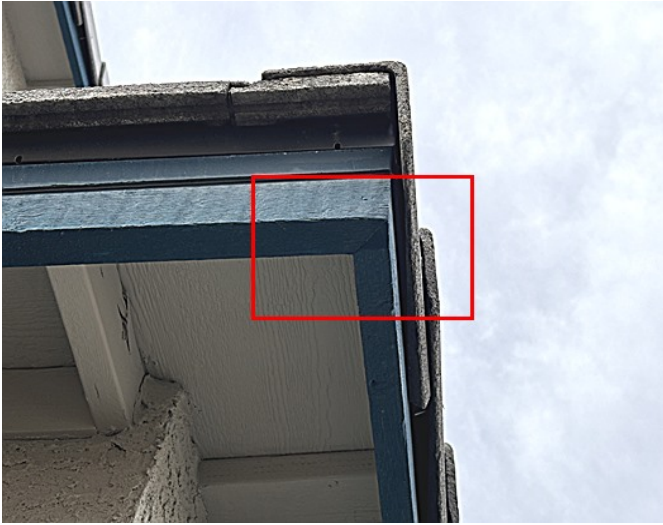
Photo 13-390(1): front left corner

13-390: Fascia loose at joint. [B] [R]

LOCATION BELOW PHOTOS: MULTIPLE LOCATIONS: Several mending plates are observed to be missing at the jointed areas of the fascia. Left uncorrected this condition may allow separation and warping to occur. This finding does not appear to conform to building standards and practices in effect at the time of construction or installation. It is recommended the builder or responsible prime contractor review this issue and correct as required in order to provide conformance with residential construction performance standards. The photographs depicted are only representative photographs of this finding.

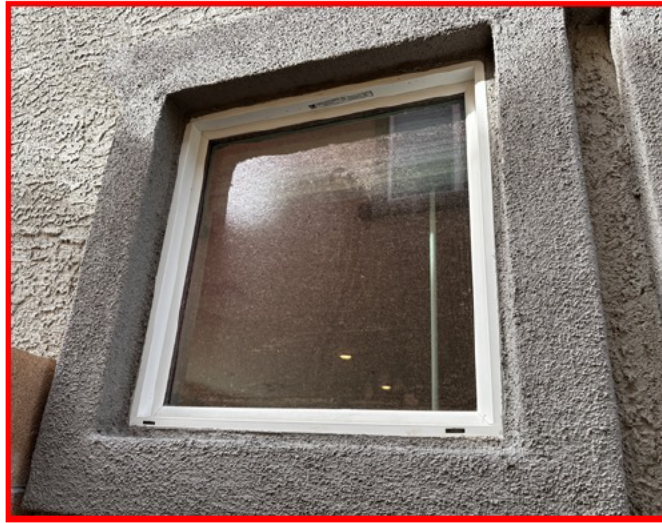
Photo 14-130(1):

14-130: Window glazing damaged. **[B] [D]**

NEAR THE FRONT ENTRY : The glazing on the outer inner pane of glass has damaged glazing and is spotting. This issue doesn't conform to manufactures installation recommendations. It is recommended the builder or responsible prime contractor review this issue and correct as required in order to provide conformance with residential construction performance standards.

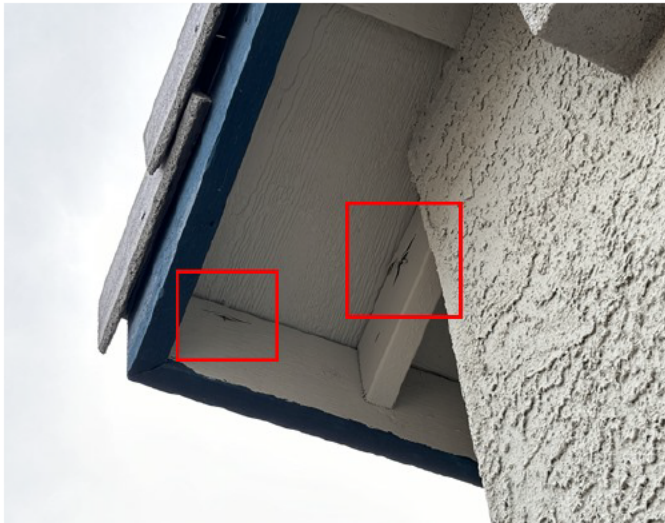
Photo 17-120(1): front left near walkway

17-120: Paint, stains, damage and building material noted on surfaces not intended. **[B] [R]**

LOCATION BELOW PHOTOS: MULTIPLE LOCATIONS: Refer to the photographs for further clarification. Our inspection service is a general review of the overall property condition and there were many more sub-standard locations than what was depicted in this report. It is recommended the builder or responsible prime contractor review this issue and correct as required in order to provide conformance with residential construction performance standards.

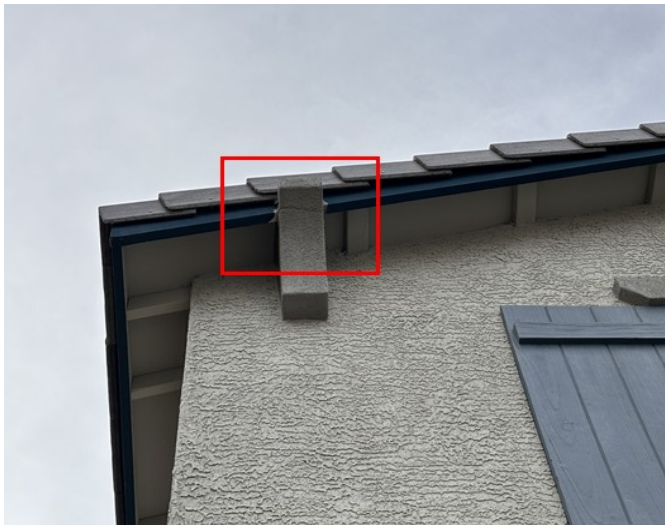
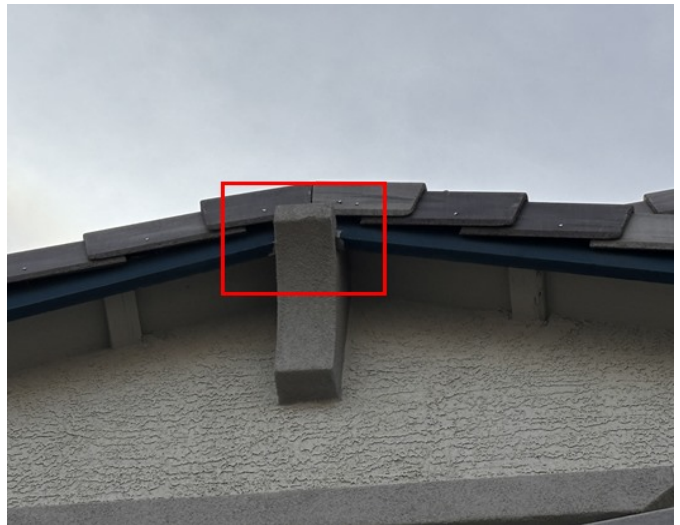
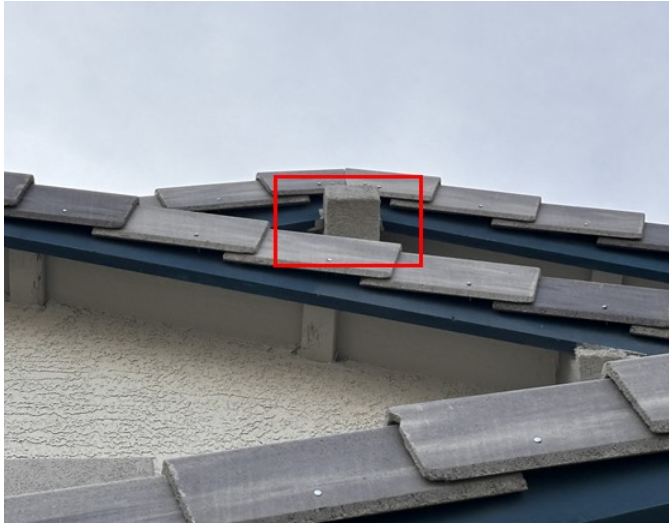
17-125: Paint observed not in conformance with performance standards. **[B] [R]**

LOCATION BELOW PHOTOS: MULTIPLE LOCATIONS: The industry standard for painting is outlined in the Painting Contractors Association Industry Standards. Specifically, the standard, PDCA P1 2.6 delineates The painting and decorating contractor will produce a “properly painted surface.” A “properly painted surface” is defined as uniform in appearance, color, texture, hiding and sheen. It is also free of foreign material, lumps, skins, runs, sags, holidays, misses, or insufficient coverage. It is also a surface free of drips, spatters, spills or overspray caused by the painting and decorating contractor’s workforce. In order to determine whether a surface has been “properly painted” it shall be examined without magnification at a distance of thirty-nine (39) inches or one (1) meter, or more, under finished lighting conditions and from a normal viewing position.” It is recommended the builder or responsible prime contractor review this issue and correct as required in order to provide conformance with residential construction performance standards.

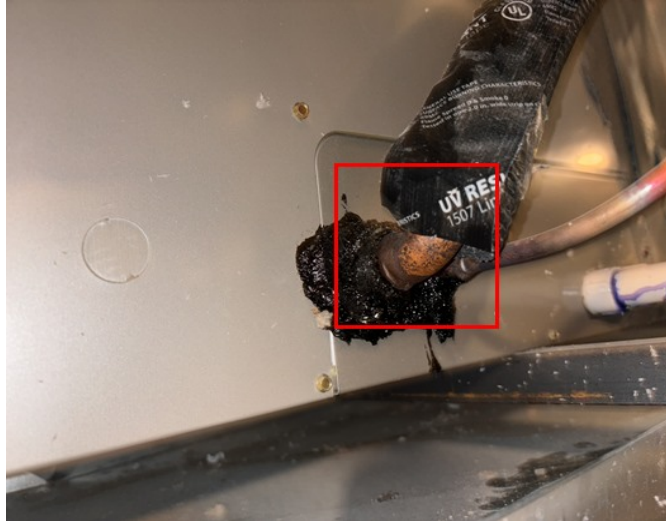
Photo 23-140(1):

23-140: Refrigerant line insulation gapped. [B]

ATTIC: In addition to resulting in a loss of efficiency this condition can allow condensate to form on the exposed piping and drip into the area below the piping resulting in water damage. This issue doesn't conform to manufactures installation recommendations. It is recommended the builder or responsible prime contractor review this issue and correct as required in order to provide conformance with residential construction performance standards.

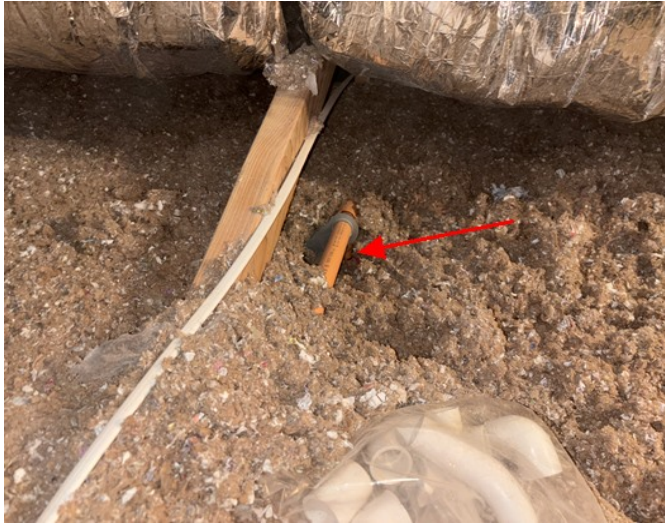
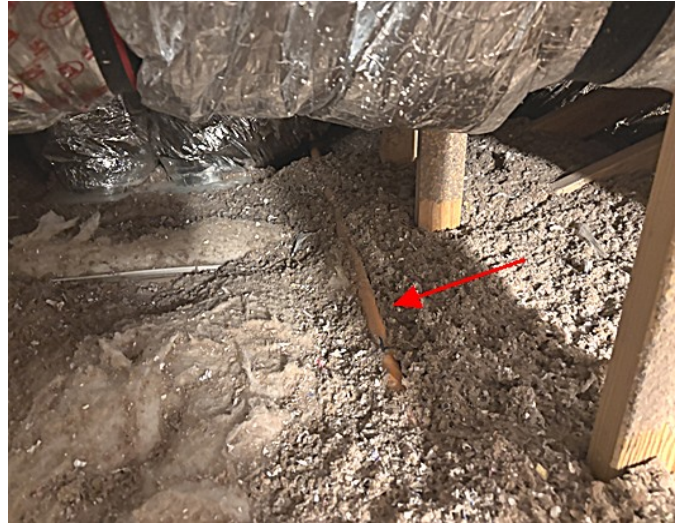
42-180: Fire sprinkler piping not protected from freeze. **[R] [B]**

ATTIC: Any photographs depicted are only representative photographs of this finding. According to The National Fire Sprinkler Association (NFSA) Insulation for Fire Sprinklers Guide, Fire sprinkler systems have proven to be effective in providing protection of lives and property when properly designed, installed, and maintained. Areas where temperatures reach or drop below freezing at any point throughout the year require sprinkler systems to be protected against freezing. The industry accepted practice is to provide protection for water-filled piping in sprinkler systems when they are subject to freezing and exposed to temperatures below 40 °F (4°C) as required in NFPA sprinkler installation standards. This finding did not appear to meet building standards and practices in effect at the time of construction or installation. It is recommended the builder or responsible prime contractor review this issue and correct as required in order to provide conformance with residential construction performance standards.

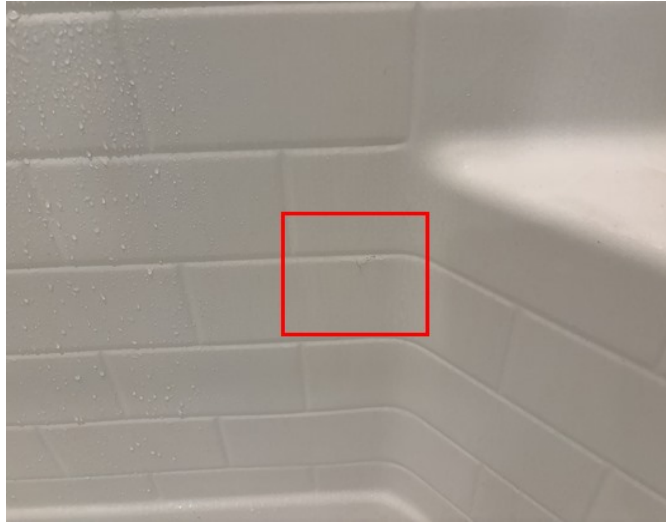
Photo 61-365(1):

61-365: Shower / tub fiberglass damaged. [DI] [R]

MAIN BATHROOM: Tubs and shower pans should be free of cracks. Report to the contractor at the homeowner walk through any tub or shower pan cracks. Contractor should repair tub or shower pan, during the warranty period, if crack is identified and determined to be the result of a defect in material or installation. If it is necessary to replace a fixture the contractor will make all reasonable efforts to match surrounding materials as closely as practical; however, the contractor does not guarantee an exact match. Tubs and shower pans should not crack with normal use and care. It is recommended the builder or responsible prime contractor review this issue and correct as required in order to provide conformance with residential construction performance standards.

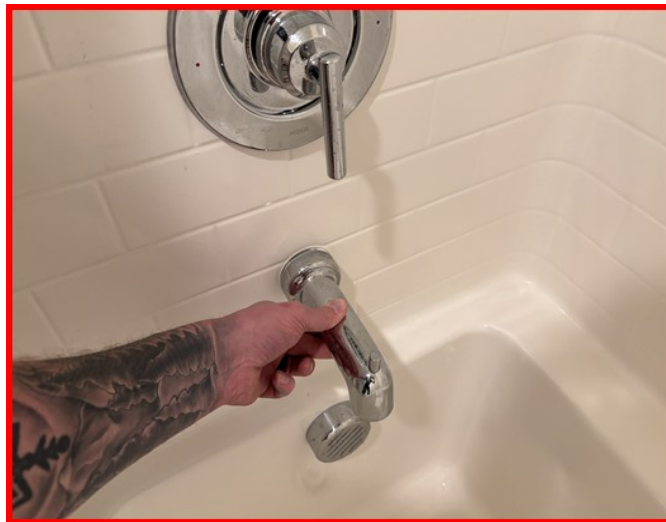
Photo 61-595(1):

61-595: Tub spout loose / not secure. [B] [N]

UPPER HALL BATHROOM: These loose components can cause the fittings to weaken and result in a leak. The appropriate maintenance should be performed to restore the component to proper condition. It is recommended the builder or responsible prime contractor review this issue and correct as required in order to provide conformance with residential construction performance standards.

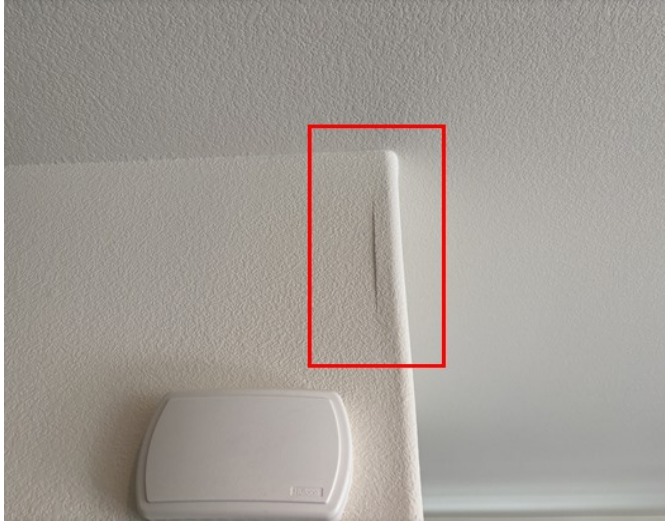
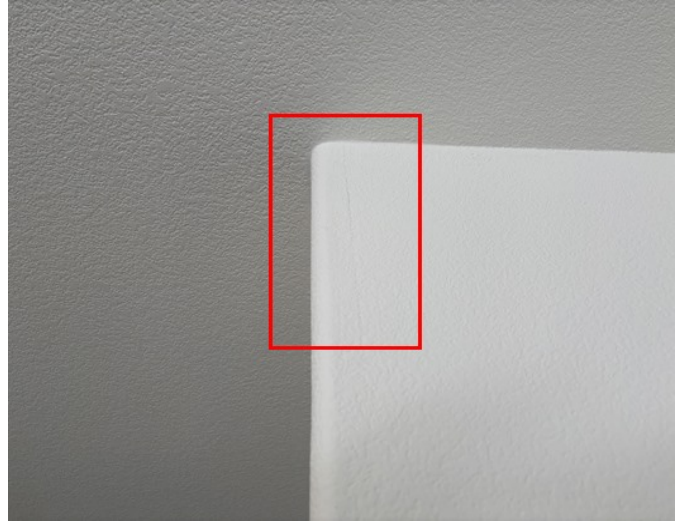
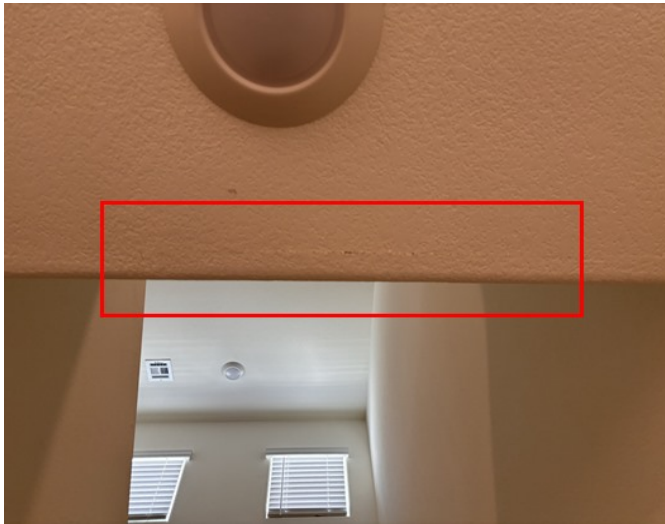
71-165: Corner beads showing. [B] [R]

MULTIPLE LOCATIONS DOWN STAIRS NEAR THE HALF BATHROOM : All joints should be installed in such a manner that they will blend with the surrounding textures or paints, installed at the time of close, and should not be noticeable under natural lighting conditions. Report any visible flashing joints in the drywall to the contractor. Contractor should repair as needed during the warranty period. If repairs are required, contractor will make all reasonable efforts to match existing materials and textures as closely as possible, however, the contractor does not guarantee an exact match of either texture or color.

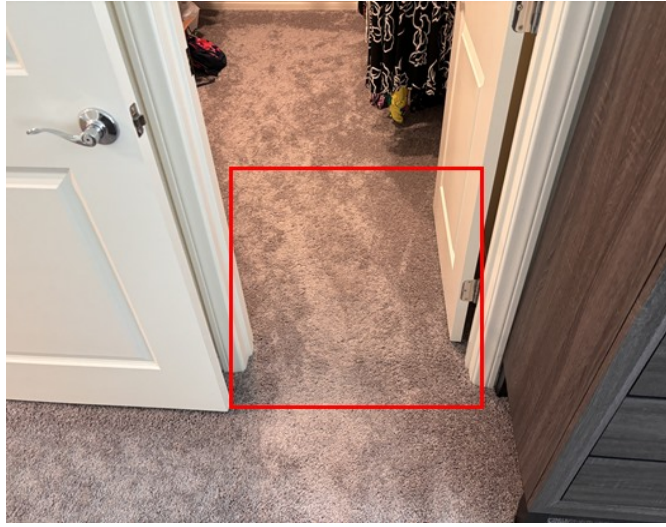
Photo 72-115(1):

72-115: Floor or flooring creaks. [B] [R]

MAIN BEDROOM CLOSET : Floors should not squeak at the time of the walk or closing. Over time of walking on the floor, noises can appear. Slight floor noises are considered normal. Report squeaky floors to the contractor. Contractor should repair the squeaks as necessary during the warranty period. A squeak-proof floor cannot be guaranteed due to seasonal weather conditions that cause the framing to expand and contract. It is recommended the builder or responsible prime contractor review this issue and correct as required to provide conformance with residential construction performance standards.

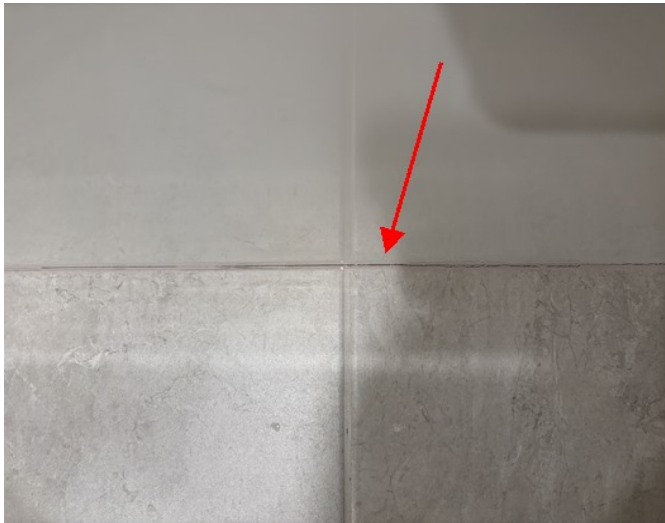
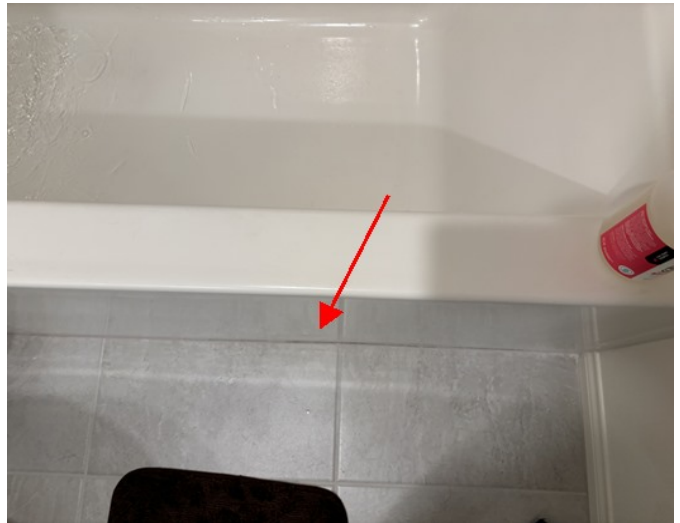
72-220: Floor tile or stone cracked. **BI|R**

MULTIPLE LOCATIONS IN THE BATHROOMS : Tiles should not be cracked, or loose. Hollow sounding tile is acceptable if not extensive and tile is solidly bonded. Report cracked or loose tile to the contractor. Contractor should repair or replace the cracked or loose tile during the warranty period. Contractor will make all reasonable efforts to match existing materials as closely as possible; however, the contractor does not guarantee an exact match of either texture or color. Care should be taken not to drop large heavy objects on the tile that can break or dislodge tile pieces. Significant component damage and/or ongoing damage apparent. Corrections advised. It is recommended the builder or responsible prime contractor review this issue and correct as required in order to provide conformance with residential construction performance standards.

Photo 72-220(1): upper hall bath

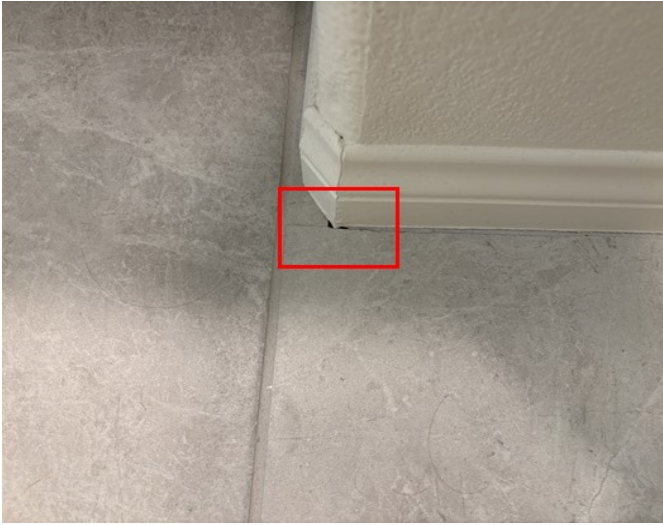
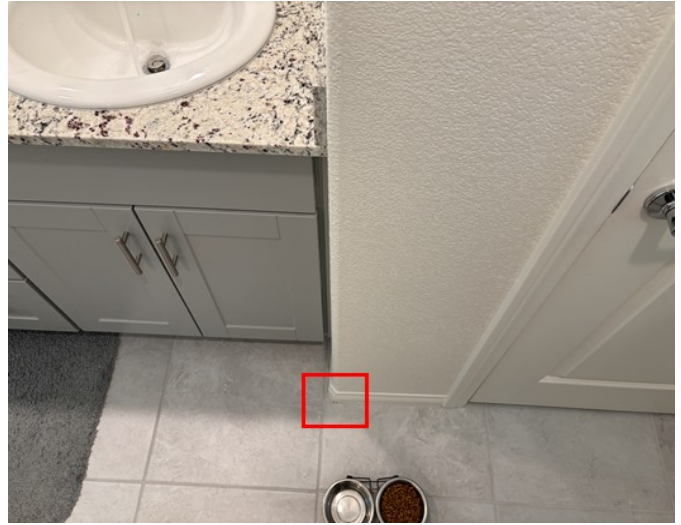
Photo 72-220(3): master

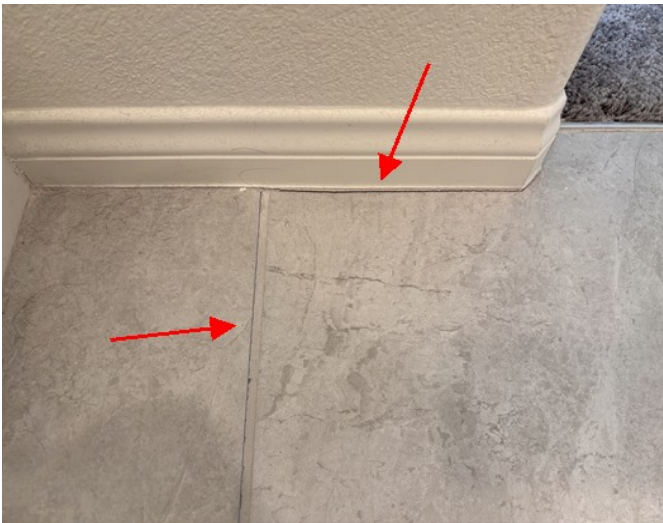
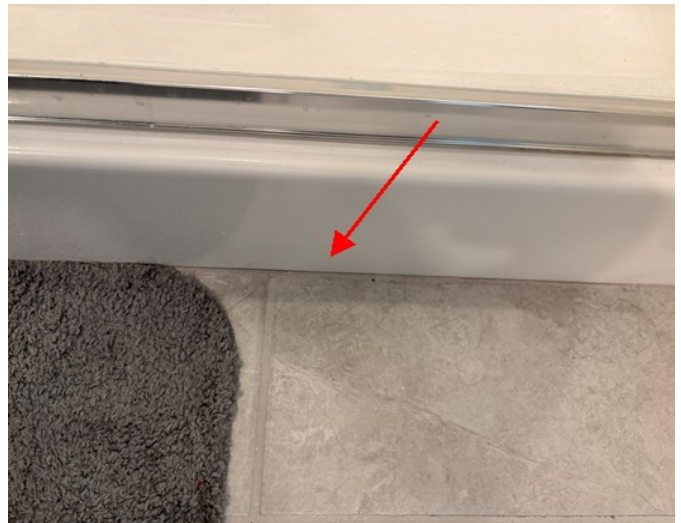
Photo 72-220(5): near master shower

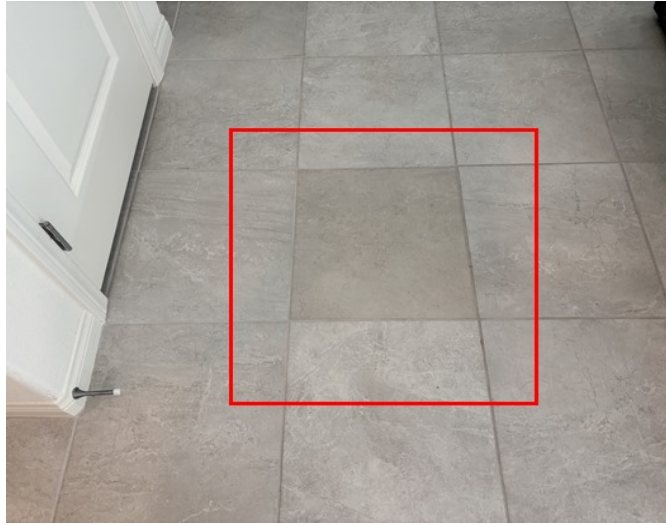
Photo 72-235(1):

72-235: Floor tile or stone faulty or otherwise amiss. **B1**

LIVING ROOM: The tile near the front entry closet is a different color than the rest of the installed tile. This issue doesn't conform to manufacturers installation recommendations. It is recommended the builder or responsible prime contractor review this issue and correct as required in order to provide conformance with residential construction performance standards.

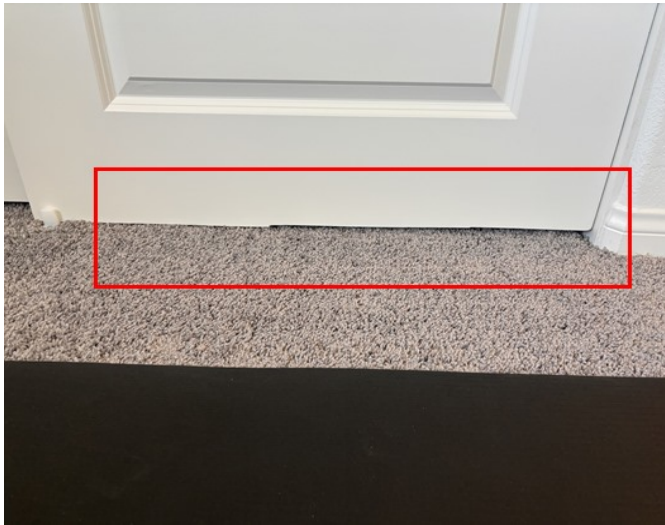
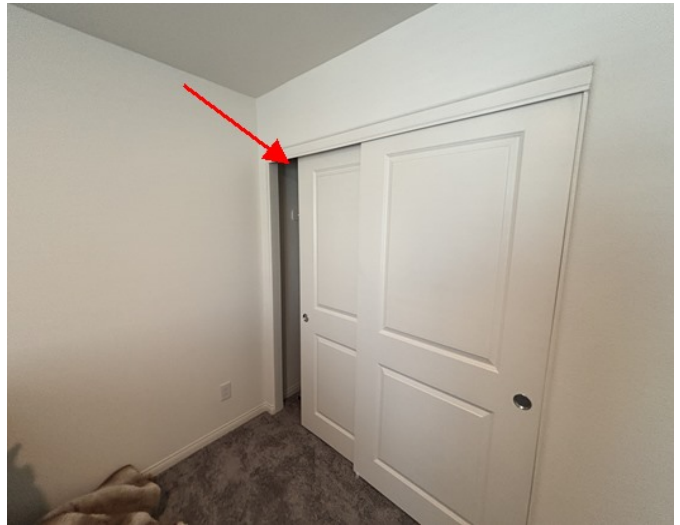
73-370: Bypass door faulty or otherwise amiss. **[B]**

BOTH SPARE BEDROOMS : The door in the N/W bedroom has been cut not in a straight line and the closet door in the N/E guest bedroom doesn't open and close freely. This issue doesn't conform to manufactures installation recommendations. It is recommended the builder or responsible prime contractor review this issue and correct as required in order to provide conformance with residential construction performance standards.

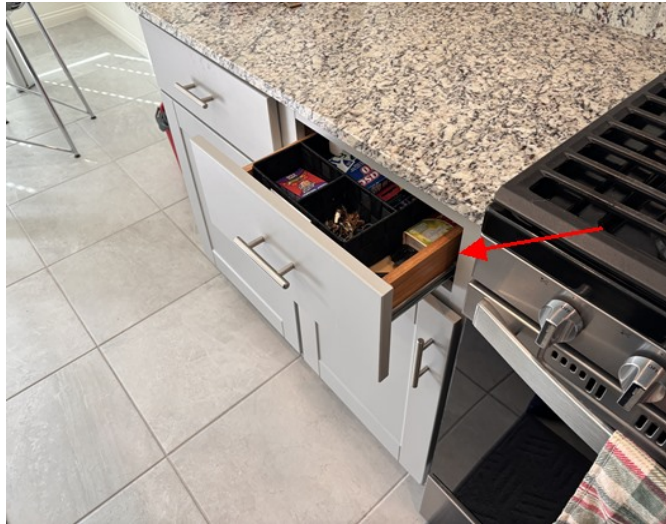
Photo 87-265(1):

87-265: Cabinet drawer(s) difficult to operate. [B]

KITCHEN : The drawer near the oven is grabbing and doesn't operate properly. This issue doesn't conform to manufactures installation recommendations. It is recommended the builder or responsible prime contractor review this issue and correct as required in order to provide conformance with residential construction performance standards.

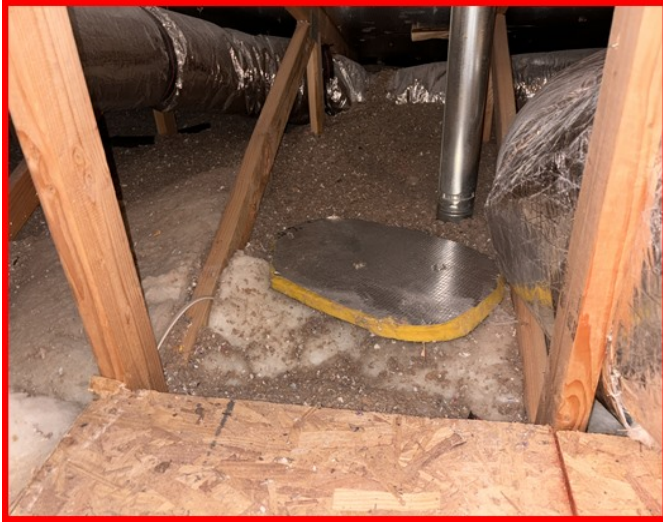
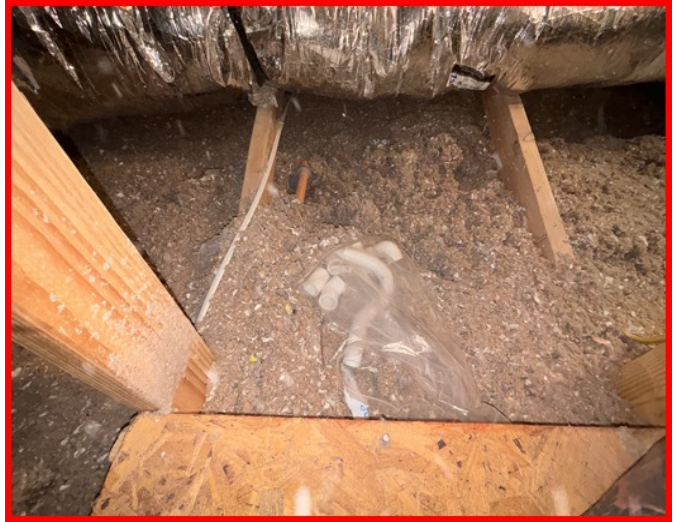
94-195: Debris present in attic. [B] [R]

ATTIC: What appeared to be excessive construction debris was noted. This finding does not appear to conform to building standards and practices in effect at the time of construction or installation. It is recommended the builder or responsible prime contractor review this issue and correct as required in order to provide conformance with residential construction performance standards. The photographs depicted are only representative photographs of this finding.

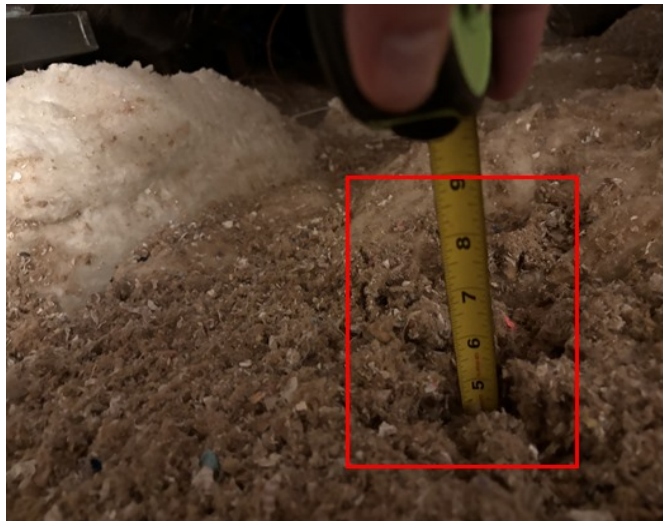
Photo 95-110(1):

95-110: Insulation appeared to be insufficient. [B] [R]

ATTIC: When reviewing the blown-in cellulose fiber insulation in the attic, several areas were observed where insulation was less than the thickness needed to provide R-30 insulation value; the minimum requisite for our region. To achieve R-30 insulation value, unsettled cellulose fiber insulation should measure approximately 9 inches thick, which will eventually become approximately 8 inches thick when settled. It is expected that cellulose, even stabilized, will settle as much as 20% of the applied thickness. Cellulose insulation will likely continue to settle for up to two years; however, most of the settling will occur in the first several months. Unfortunately, insufficient insulation is a common issue in Las Vegas. Municipal inspectors do not carry ladders and physically review insulation levels. The builder merely provides the municipal inspector with a certificate attesting that the minimum required amount of insulation has been provided; the certificates are often inaccurate. It is recommended the builder or responsible prime contractor review this issue and correct as required in order to provide conformance with residential construction performance standards.

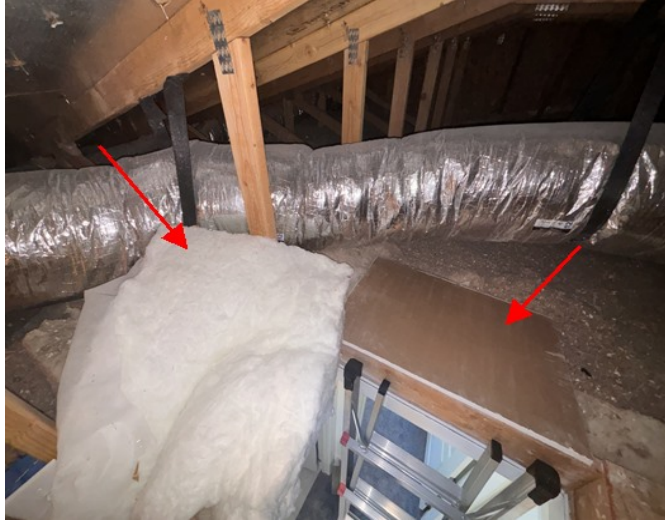
Photo 95-116(1):

95-116: Attic scuttle cover not insulated. [B] [E]

ATTIC: The backside of the cover(s) should be properly insulated to maintain the requisite ceiling R-value. Often, the insulation is never installed or becomes displaced. Repair, alteration or replacement usually improves the efficiency of the component or system. It is recommended the builder or responsible prime contractor review this issue and correct as required in order to provide conformance with residential construction performance standards.
