The Uniform Building Inspection Report

Single Family Residence:
[REDACTED]

Inspection Company:
INSPECT LV
7345 S. Durango Dr. #B107-159
Las Vegas, Nevada 89113
(702) 210-5333

Inspector:
Andrew Aliotti, CPI
IOS.0002659-RES

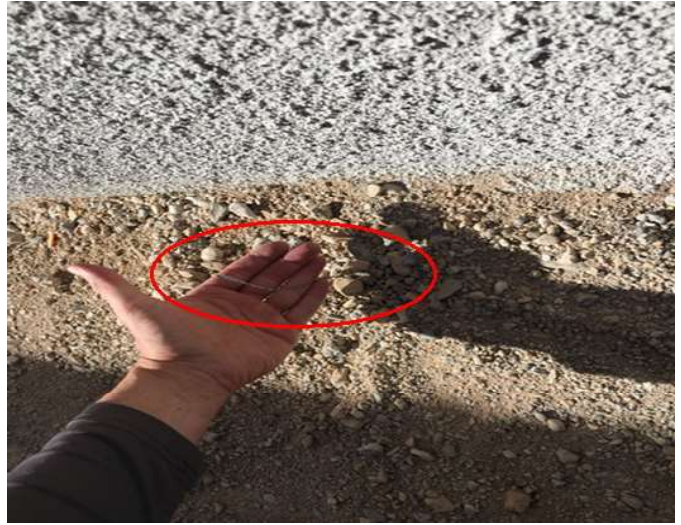
Photo 07-135(2): Rear yard

07-135: Construction debris on site. [R] [B]

MULTIPLE LOCATIONS: Nails, screws, wire, garbage and other construction debris were observed on grade in the front and rear yard area in several locations. Refer to the photographs for further clarification. The Nevada Performance Guidelines published by the Southern Nevada Home Builders Association, reviewed and accepted by the Nevada State Contractors Board states that the final grade soil should be free of construction debris to a depth of at least 5 inches. It is recommended the builder or responsible prime contractor review this issue and correct as required in order to provide conformance with residential construction performance standards.

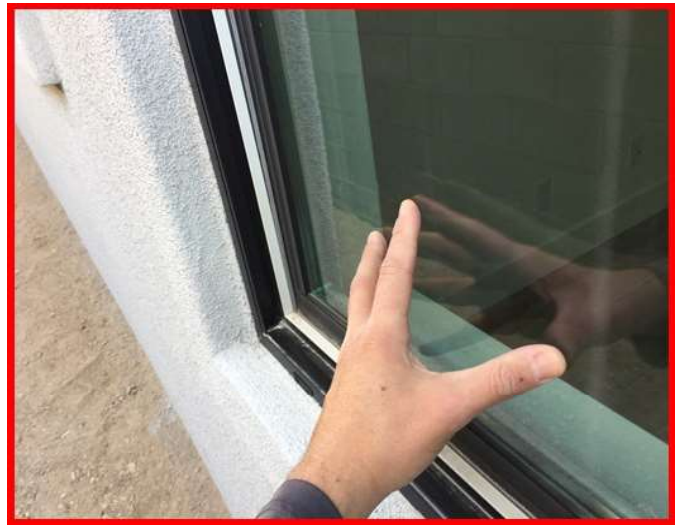
Photo 14-235(2):

14-235: Window screen(s) missing. [F] [R]

WEST BEDROOM: The installation does not appear to be in conformance with manufacturer's guidance or specifications. It is recommended the builder or responsible prime contractor review this issue and correct as required in order to provide conformance with residential construction performance standards.

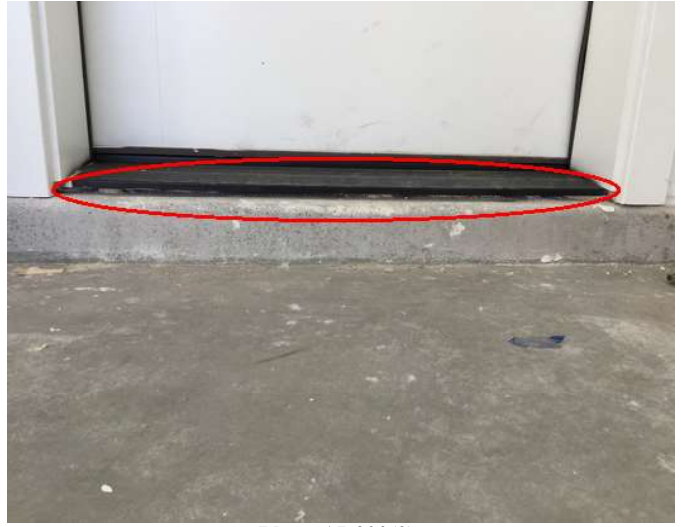
Photo 15-300(2):

15-300: Threshold improperly supported. [N] [R]

GARAGE: Movement noted when traversed. No shims or caulking was observed. The installation does not appear to be in conformance with manufacturer's guidance or specifications. It is recommended the builder or responsible prime contractor review this issue and correct as required in order to provide conformance with residential construction performance standards.

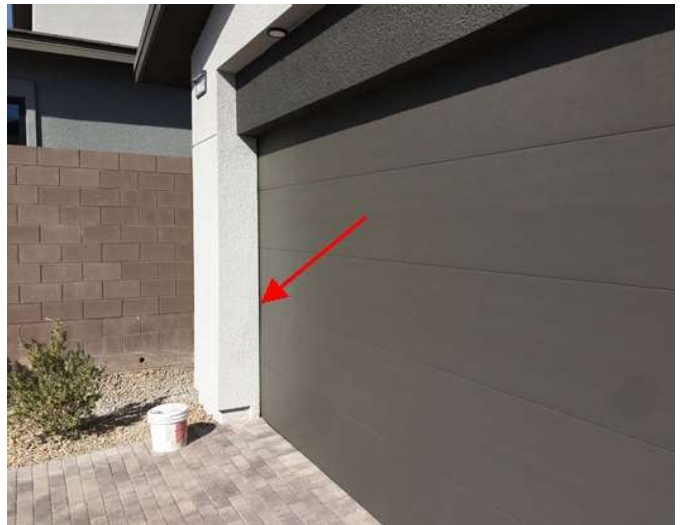
Photo 16-110(2): 2-car garage

16-110: Vehicle door out of position. [R] [B]

GARAGES: Overhead garage doors should be installed per the manufacturer installation instructions and create a seal with the garage floor at the time of the walkthrough. 1/2 inch gaps at the sides and top are the maximum acceptable measurement between the structure and the garage door. It is recommended the builder or responsible prime contractor review this issue and correct as required in order to provide conformance with residential construction performance standards. Any photographs depicted are only representative photographs of this finding.

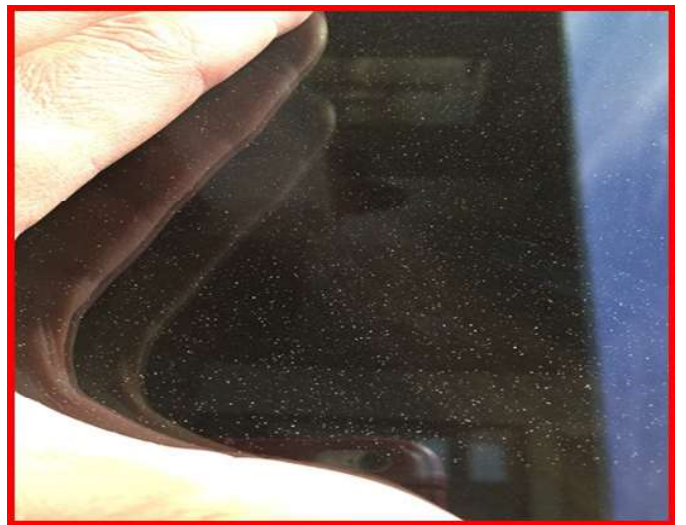
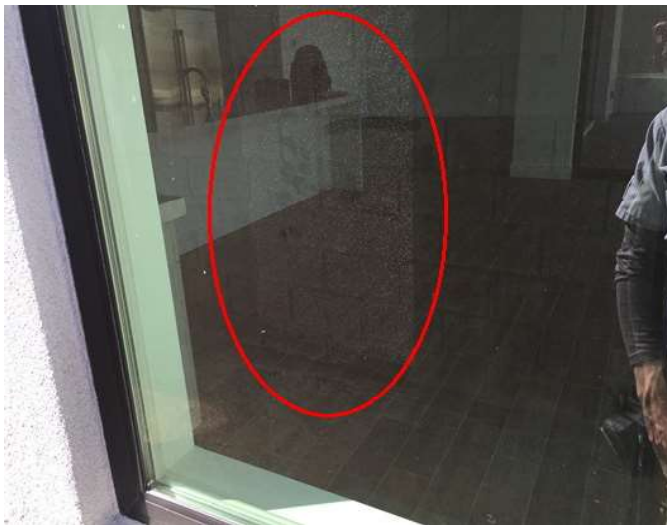
Photo 17-120(4): Paint overspray on multiple windows

Photo 17-120(5): Paint overspray on multiple windows

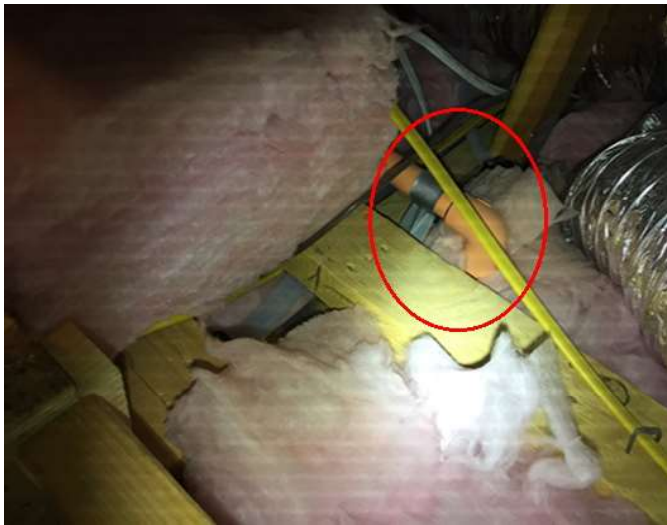
Photo 42-180(1):

42-180: Fire sprinkler piping not protected from freeze. [R] [B]

ATTIC: According to The National Fire Sprinkler Association (NFSA) Insulation for Fire Sprinklers Guide, Fire sprinkler systems have proven to be effective in providing protection of lives and property when properly designed, installed, and maintained. Areas where temperatures reach or drop below freezing at any point throughout the year require sprinkler systems to be protected against freezing. The industry accepted practice is to provide protection for water-filled piping in sprinkler systems when they are subject to freezing and exposed to temperatures below 40 °F (4°C) as required in NFPA sprinkler installation standards. This finding did not appear to meet building standards and practices in effect at the time of construction or installation. It is recommended the builder or responsible prime contractor review this issue and correct as required in order to provide conformance with residential construction performance standards.

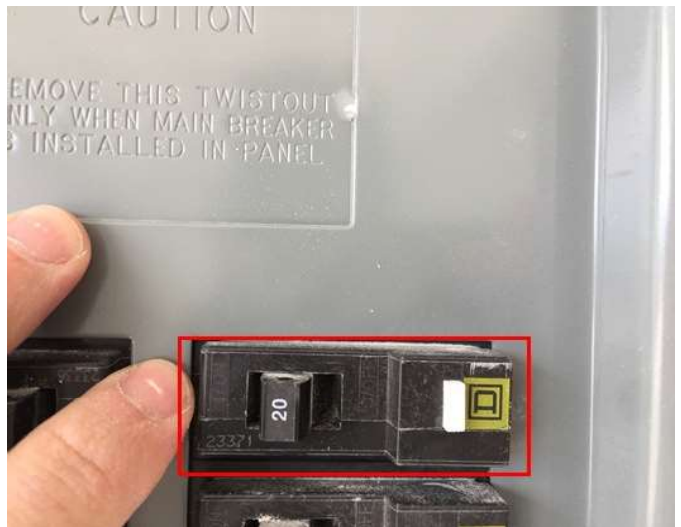
52-390: Electrical breaker found in open / off position. [N] [R]

MULTIPLE LOCATIONS: The depicted breakers were found in the open/off position. A circuit found in the off position may be that way due to an unsafe condition or a repair in progress. Standard practice is to leave it off and document the finding. It is recommended the builder or responsible prime contractor review this issue and correct as required in order to provide conformance with residential construction performance standards. Discretion advised. The significance of the finding is uncertain. Further study is advised.

Photo 52-390(2): Sub panel

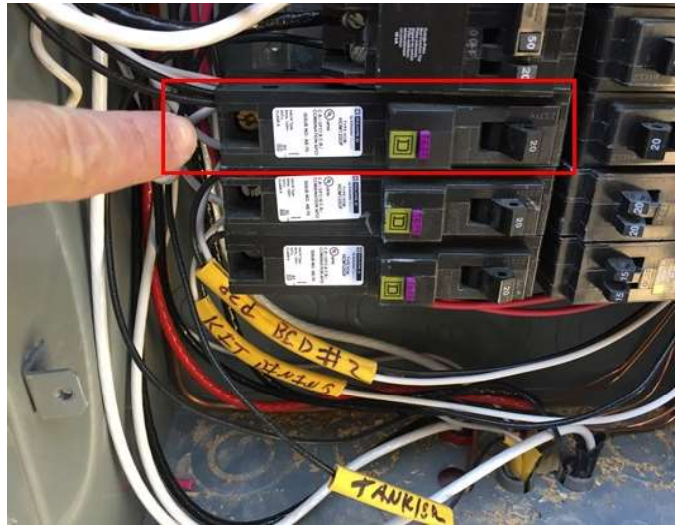
Photo 52-510(2):

52-510: Double stab observed at breaker. [B] [R]

MAIN PANEL: This finding did not appear to meet building standards and practices in effect at the time of construction or installation. It is recommended the builder or responsible prime contractor review this issue and correct as required in order to provide conformance with residential construction performance standards.

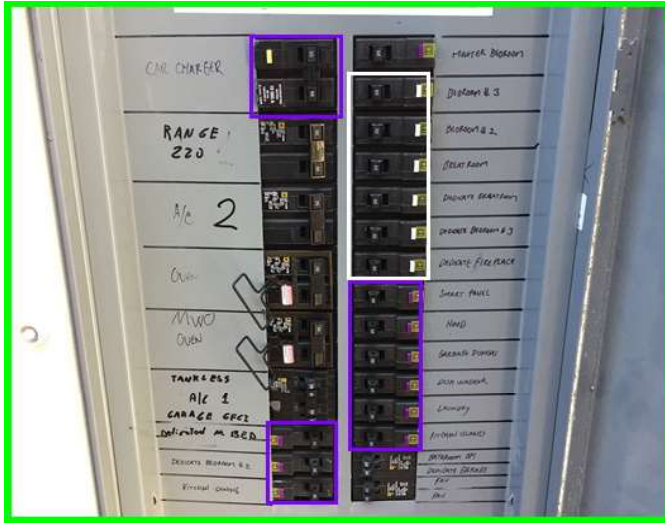
55-009: AFCI and GFCI breakers tested. [+]

These safety devices are required by current building standards and practices. All accessible breakers properly tripped when tested. These components should be tested every 30 days to ensure proper operation. This is deemed to be a positive finding.

Positive Photo 55-009(1): Purple = GFCI/AFCI combo; White = AFCI

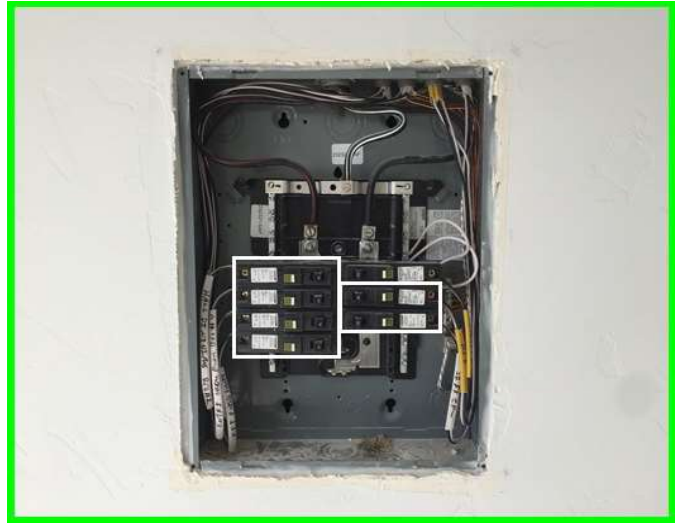
Positive Photo 55-009(2): AFCI's

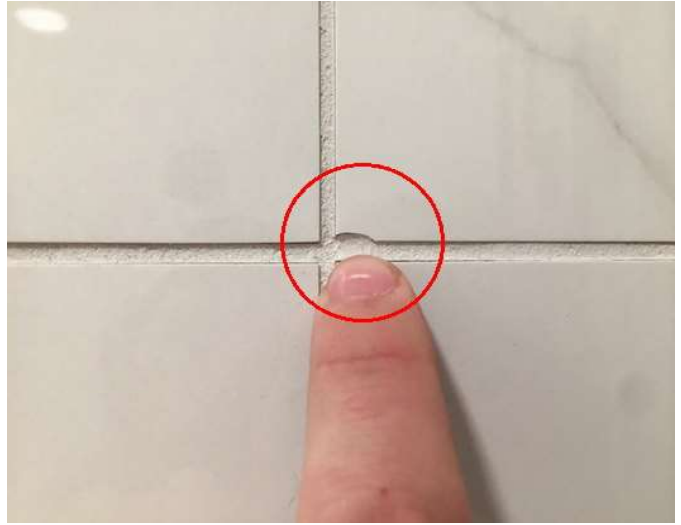
61-341: Ceramic tile installation uneven or out of line. [F] [R]

Photo 61-341(2): Hall bathroom- chipped tile

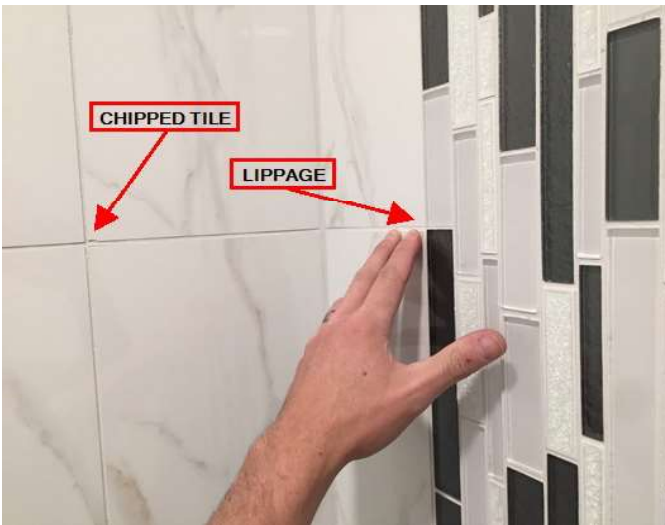
Photo 61-341(3): Hall bathroom

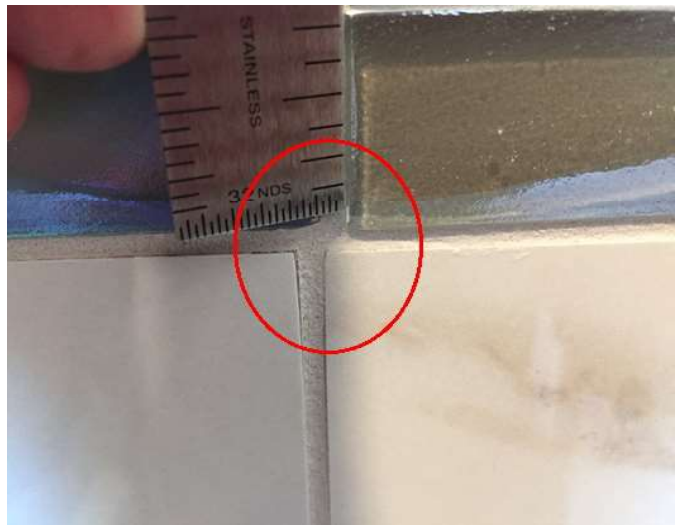
Photo 61-341(4): S/E bedroom ensuite

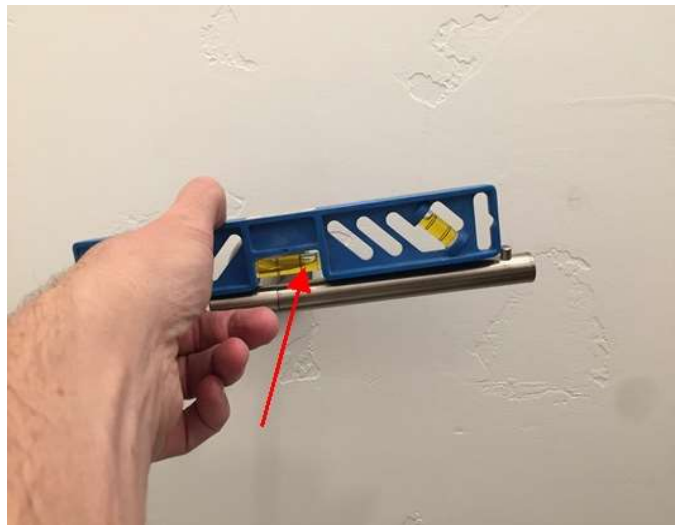
Photo 68-130(2):

68-130: Towel holder faulty or otherwise amiss. [F] [R]

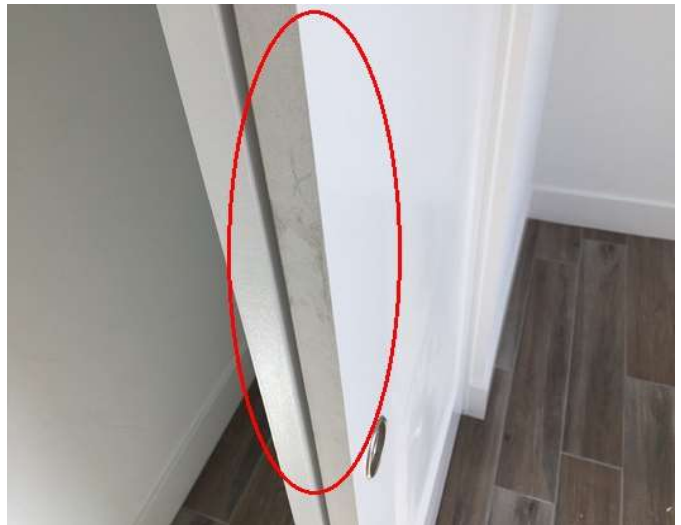
71-435: Painting observed not in conformance with performance standards. [B]

Photo 71-435(2): S/W bedroom

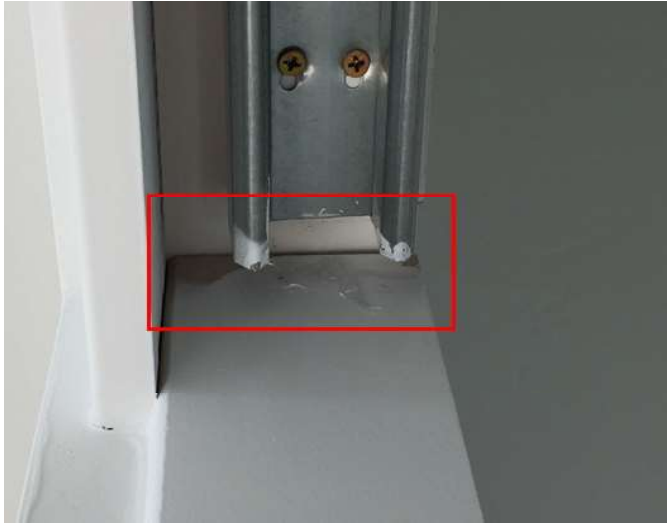
Photo 71-435(3): S/W bedroom

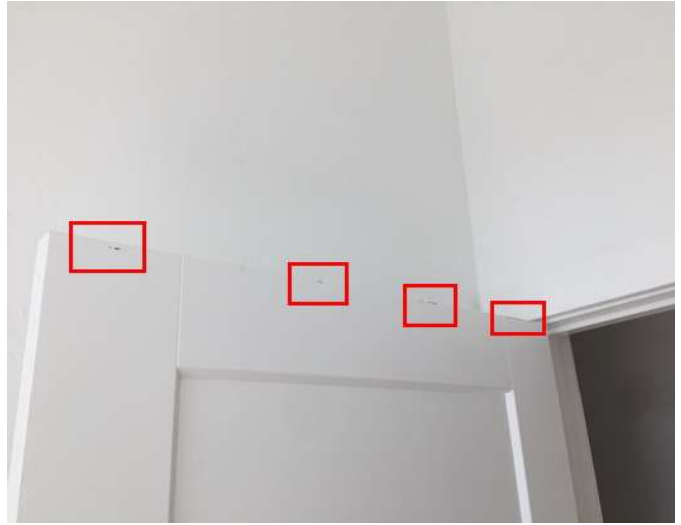
Photo 71-435(4): S/W bedroom

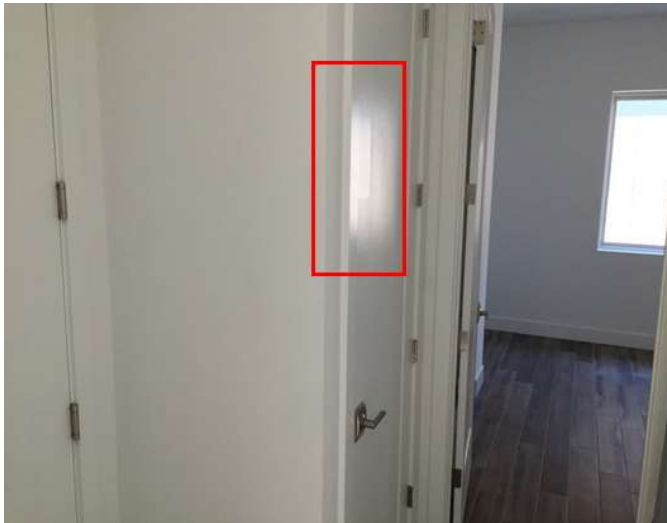
Photo 71-435(5): Hall coat closet

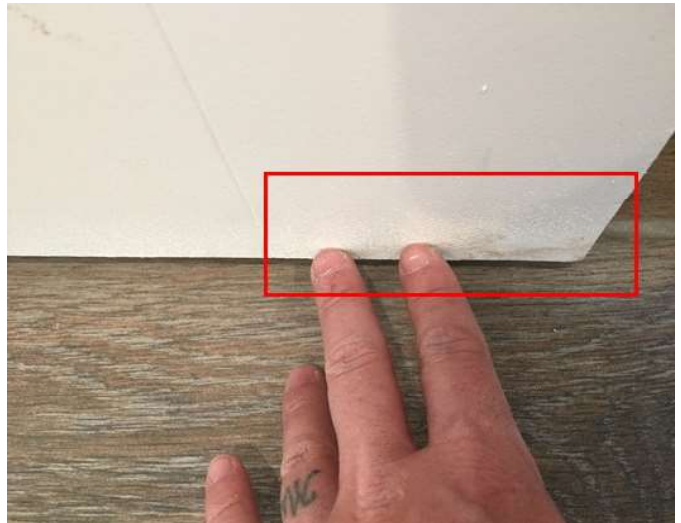
Photo 71-435(6): West bedroom

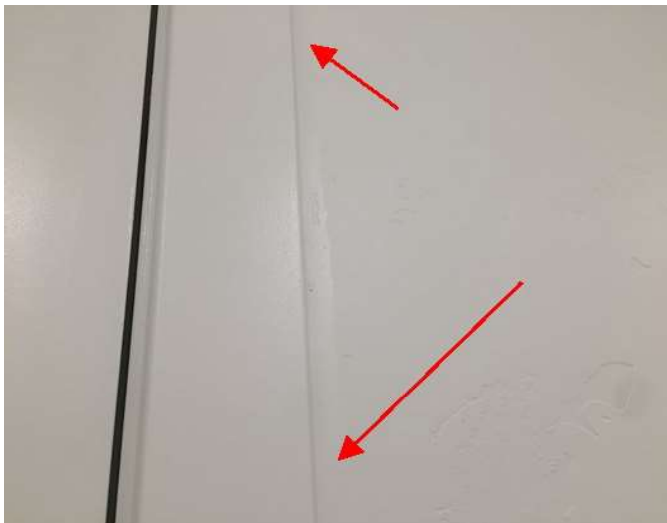
Photo 71-435(7): Hall bathroom

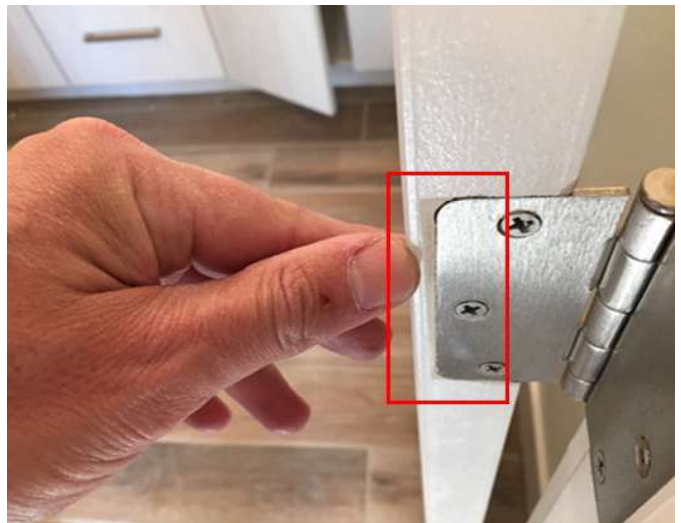
Photo 71-435(8): Hall bathroom

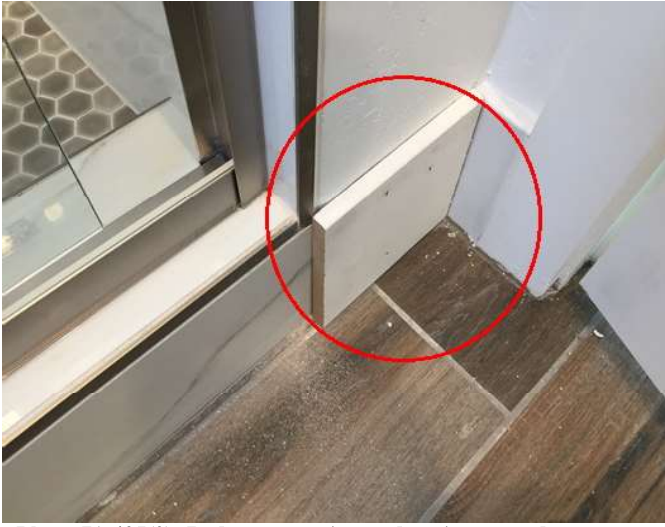
Photo 71-435(9): Bedroom ensuite- end grain exposed; no return

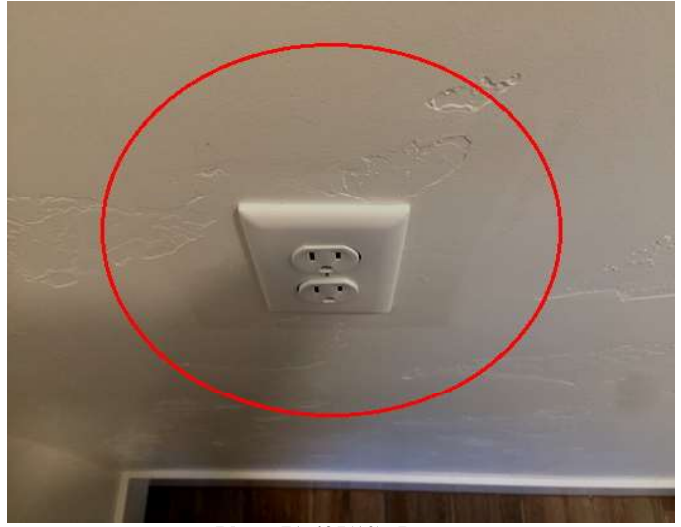
Photo 71-435(10): Pantry

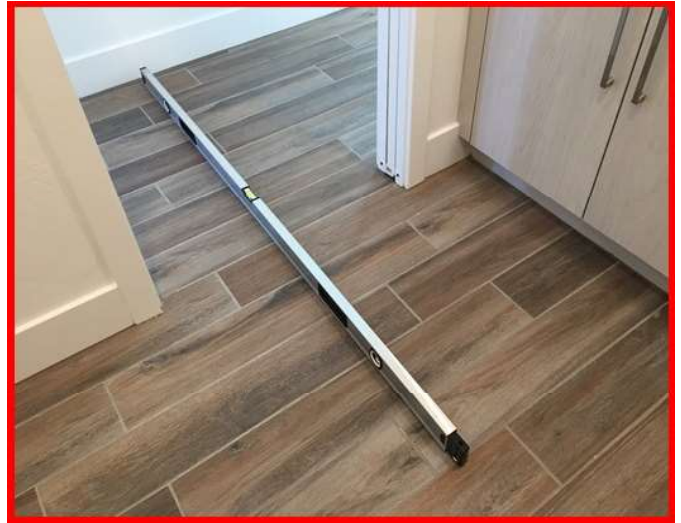
Photo 72-105(2): Laundry- 7/16" out

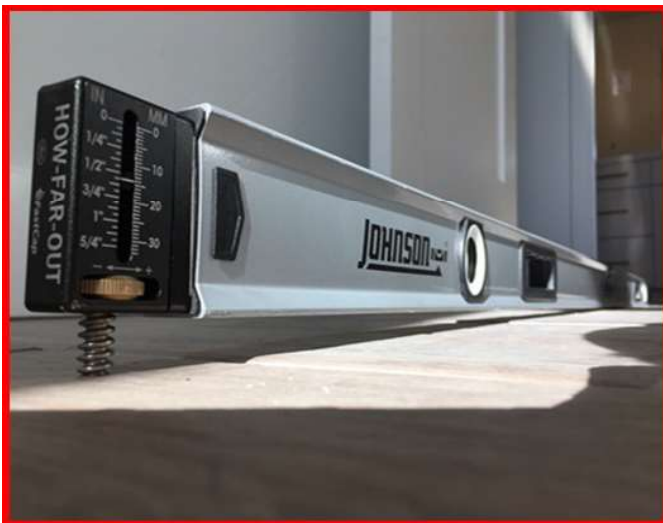
Photo 72-105(3): S/W bed- 9/16" out

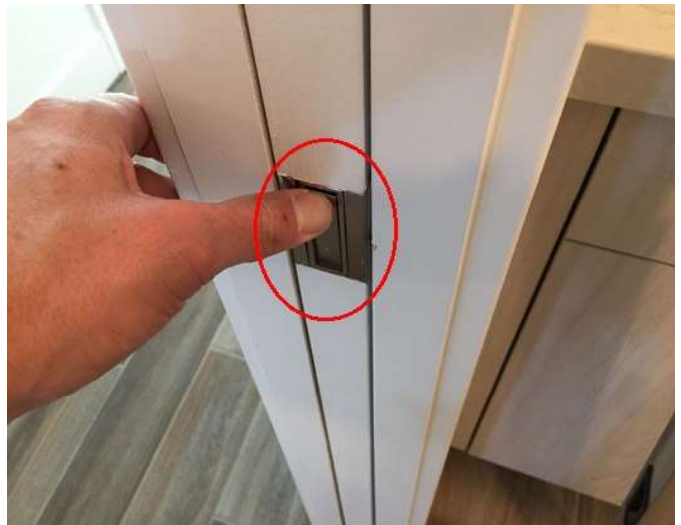
Photo 73-340(2):

73-340: Pocket door off track. [F]

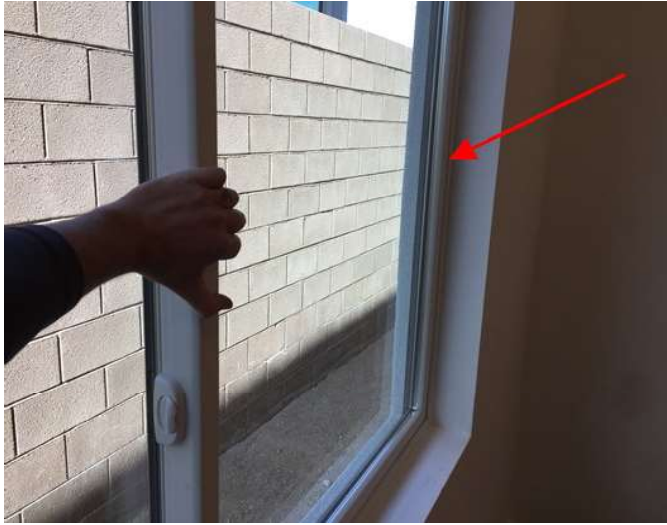
Photo 74-155(1):

74-155: Window difficult to operate. [R] [F]

WEST BEDROOM: Window would hit frame during operation, when closing. The sash may be bowed or warped slightly. Pushing outward at the location with the arrow creates enough clearance for the window to easily close. Failure of a system or component. The system or component fails to operate or to operate properly. It is recommended the builder or responsible prime contractor review this issue and correct as required in order to provide conformance with residential construction performance standards.

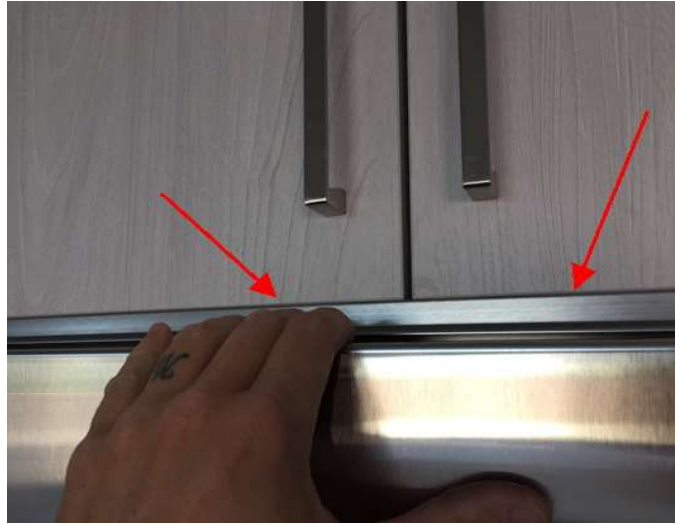
76-360: Cabinetry needs maintenance, repairs or adjustments. [F] [R]

Photo 76-360(2): Kitchen- cabinet doors above fridge drag during operation

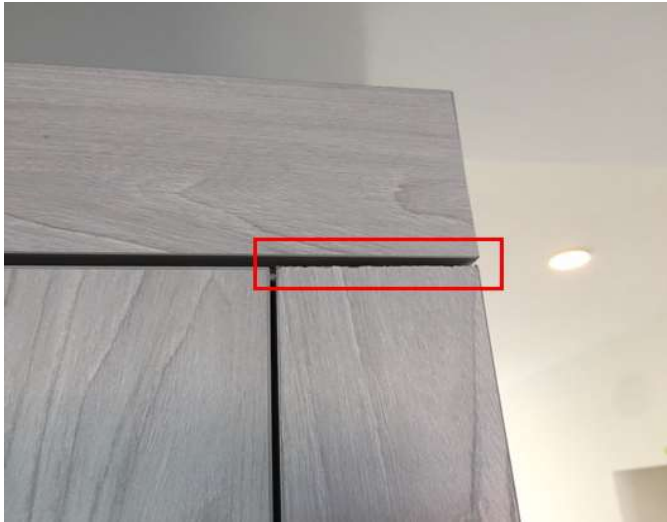
Photo 76-360(3): Kitchen- rough cut

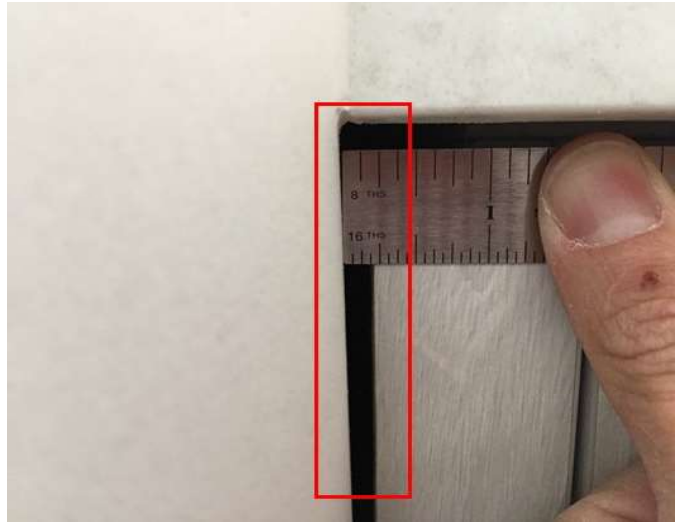
Photo 76-360(4): Kitchen- gap at sink basin

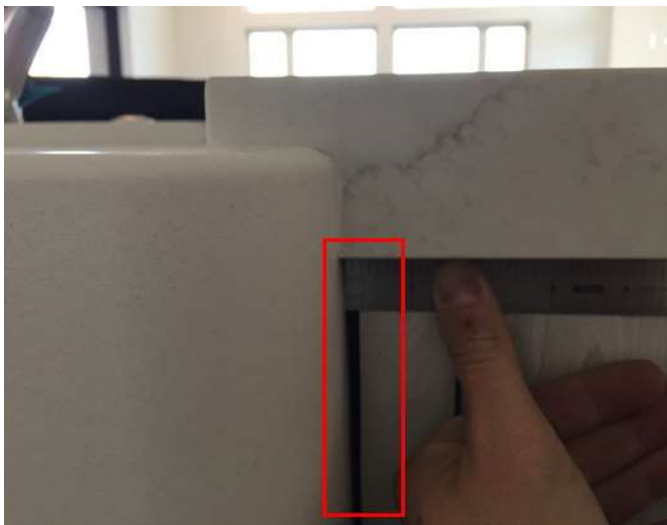
Photo 76-360(5): Kitchen- gap at sink basin

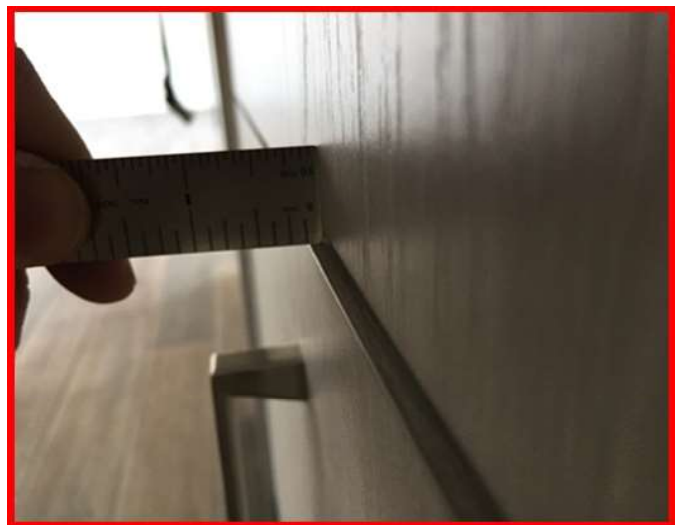
Photo 76-360(6): Kitchen

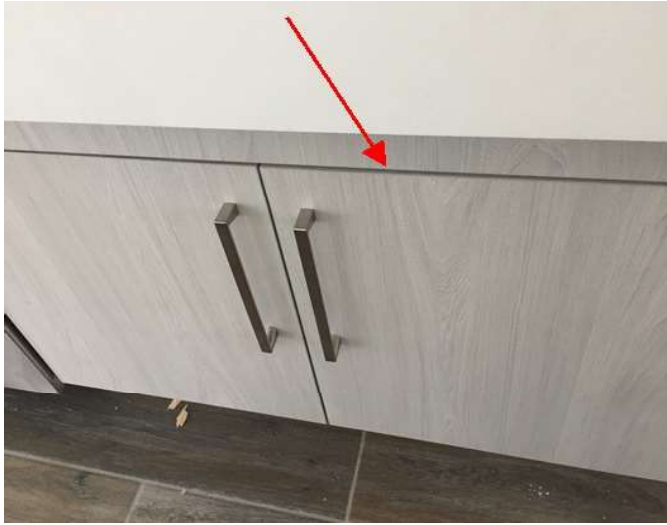
Photo 76-360(7): Kitchen

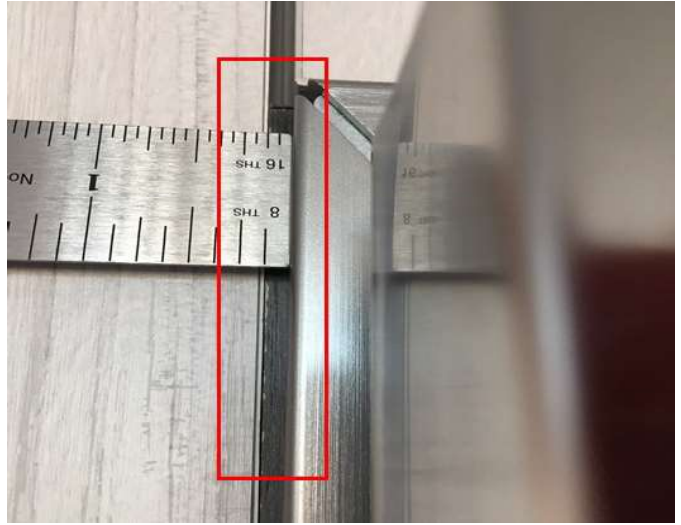
Photo 76-360(8): Kitchen- fridge trim

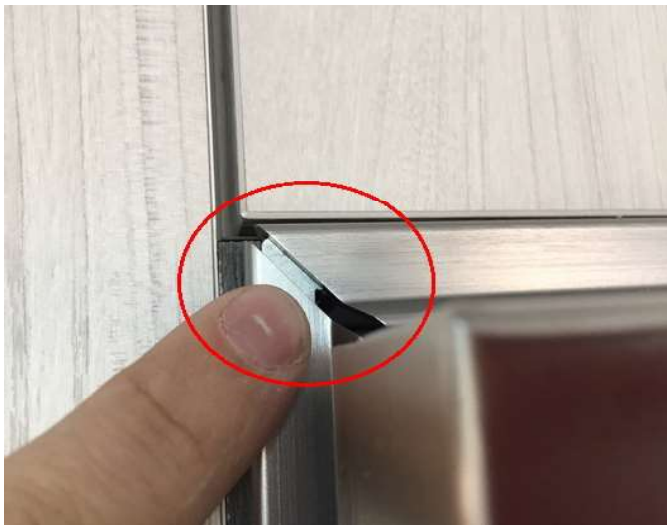
Photo 76-360(9): Kitchen- fridge trim

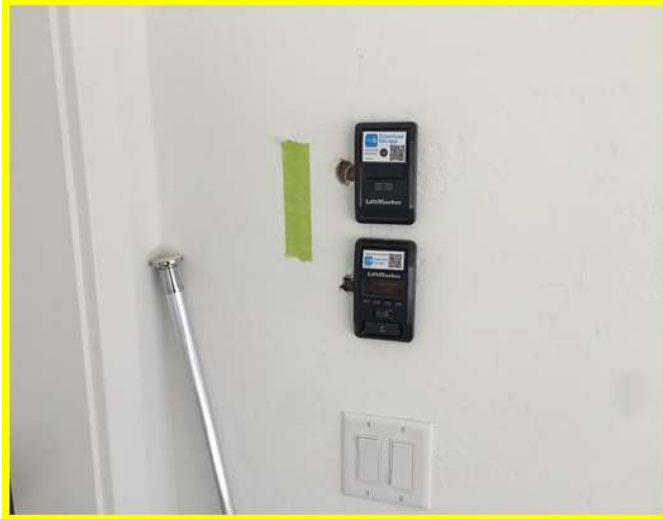
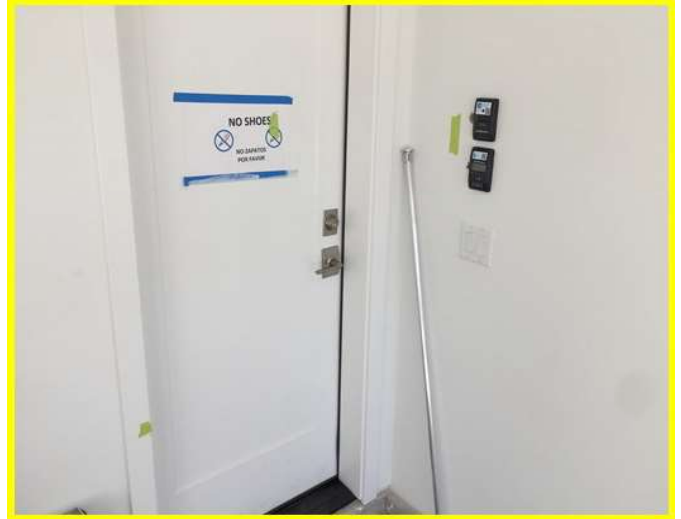
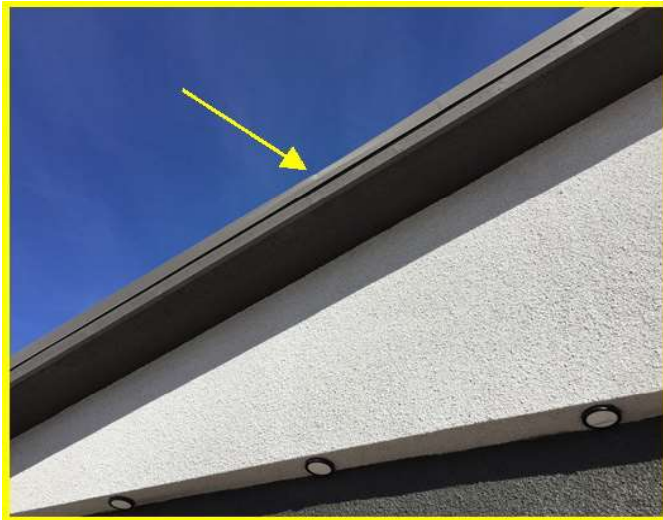
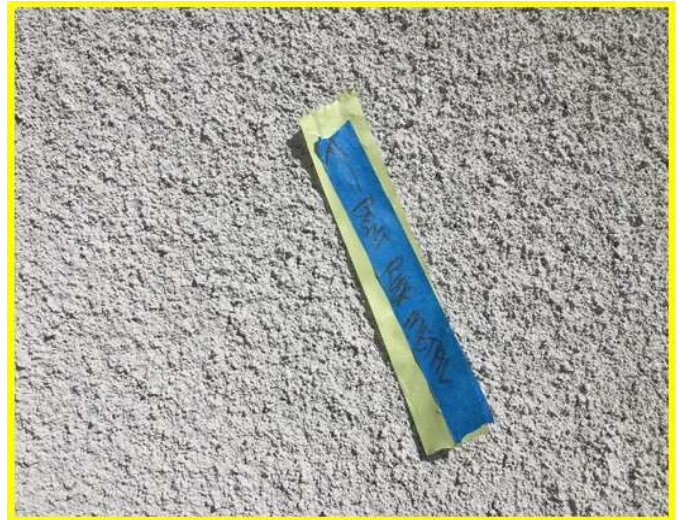
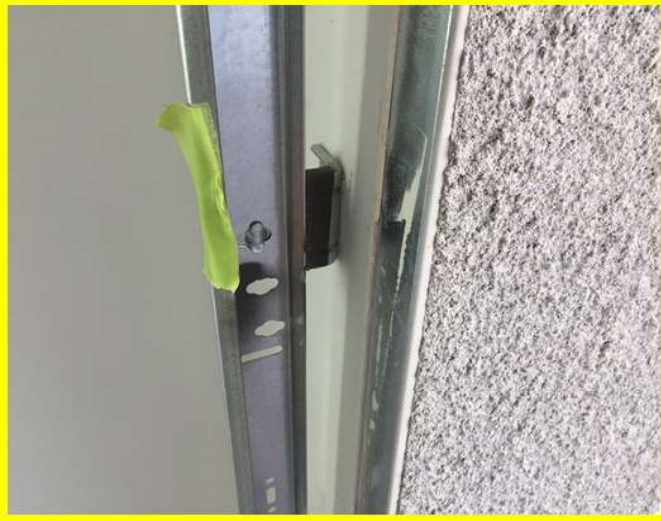
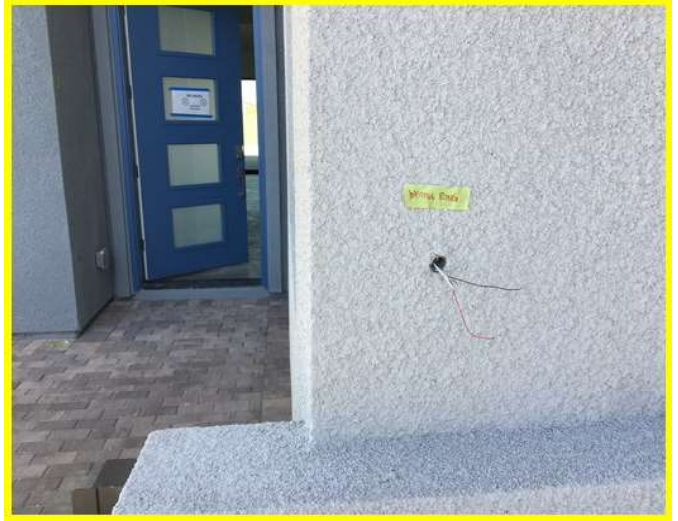
Noted at numerous locations. The builder has identified many interior and exterior areas that need attention, and flagged them with painters tape. To avoid confusion, the inspector has purposely omitted most deficiencies flagged by the builder since they are already aware of its existence. It is important to understand that the property condition will change between the time of the inspection and the final walk-through. This finding is provided for informational purposes. The photograph depicted is only a representative photograph of this finding.

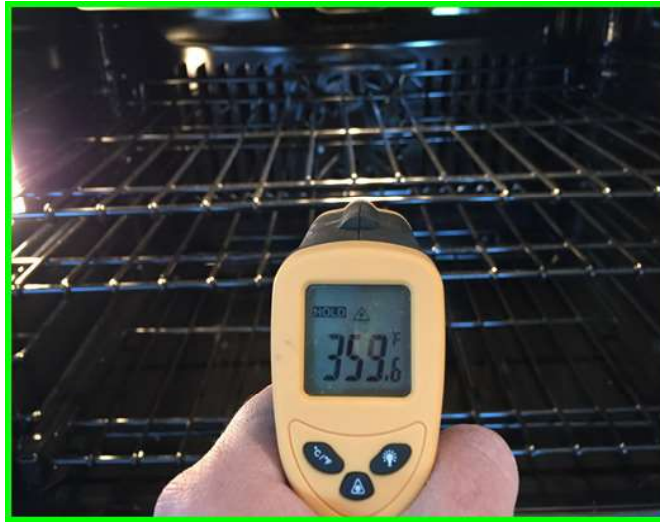
Positive Photo 81-015(1):

BUILT-IN OVEN: The oven, when tested at 350 degrees Fahrenheit, heated to 359 degrees Fahrenheit. Allowable tolerance is 350 +/- 25 degrees F, and the oven was operating within the allowable tolerance. This is a positive photo.

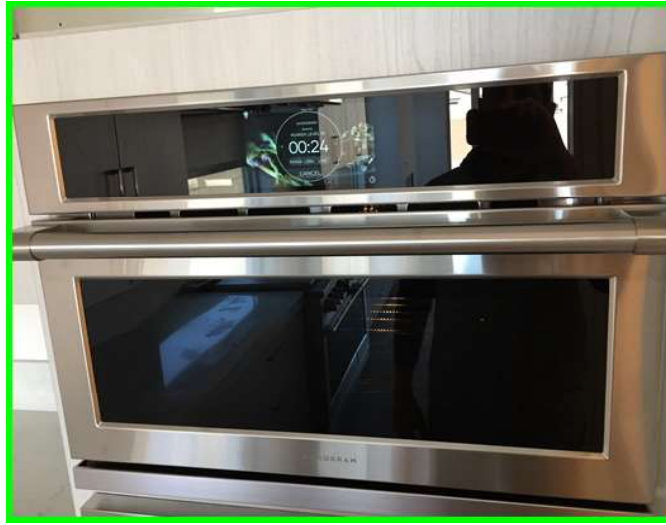
Positive Photo 81-025(1):

The inspector placed a container of room temperature water in the microwave and operated the unit for 1 minute. The unit heated the water significantly. Refer to the photograph for further clarification. This is deemed to be a positive finding.

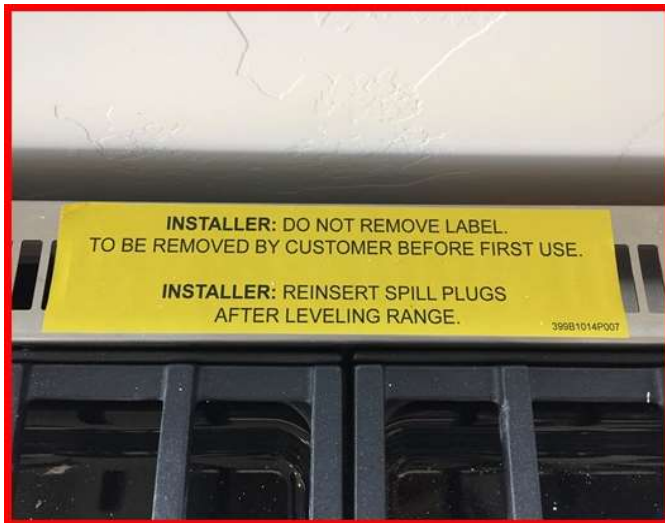
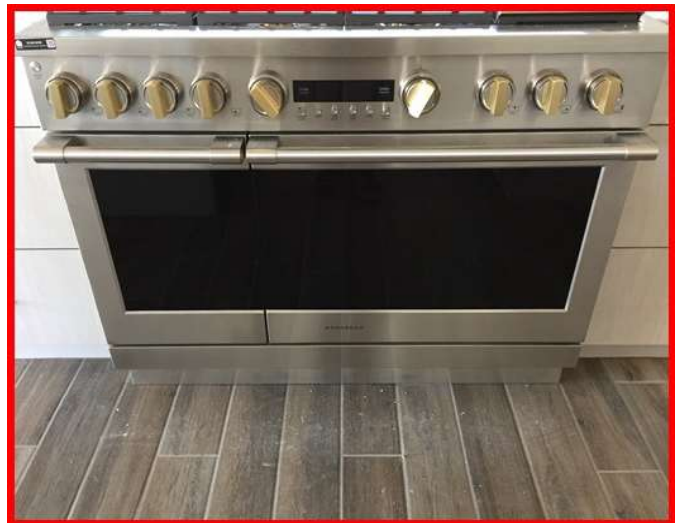
The oven range was brand new and still had packing materials affixed. This condition precluded review. The client is advised that the inspector cannot be held responsible for areas, items, or issues that the inspector could not gain access to and / or review during the course of the inspection. A thorough and complete final walk-through inspection is advised. Discretion advised. The significance of the situation, problem or defect is uncertain. Further study is advised.

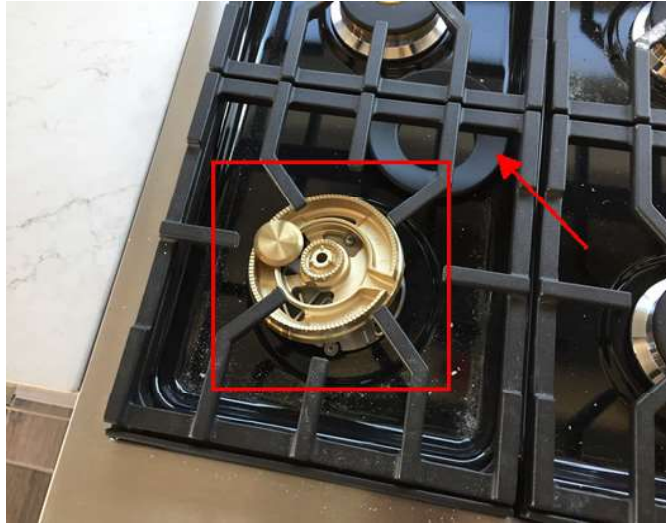
Photo 81-165(1):

The range burner appeared to be intentionally disassembled. The installation does not appear to be in conformance with manufacturer's guidance or specifications. Review of the range was precluded. Discretion advised. The significance of the situation, problem or defect is uncertain. Further study is advised.

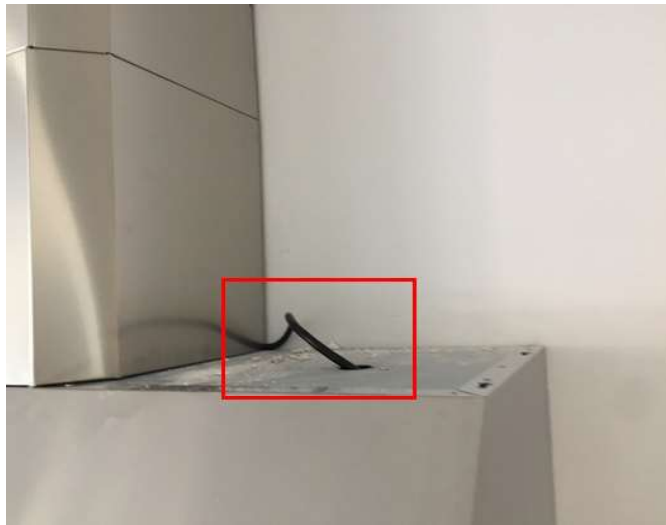
Photo 82-115(1):

The range had what appeared to be a power cord protruding from top of the unit. I recommend verifying this installation was complete and performed in accordance with manufacturer installation instruction. Discretion advised. The significance of the situation, problem or defect is uncertain. Further study is advised. It is recommended the builder or responsible prime contractor review this issue and correct as required in order to provide conformance with residential construction performance standards.

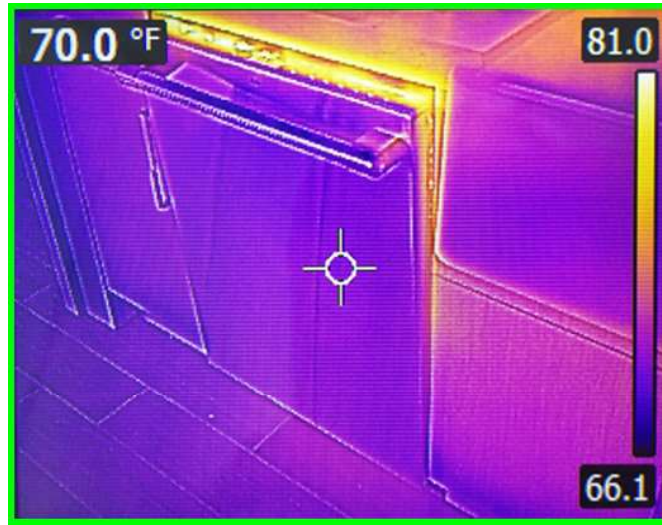
Positive Photo 83-005(1):

The client is advised that the inspector operated the dishwasher through a normal cycle with no apparent adverse mechanical or electrical conditions observed (unless noted elsewhere in this report). This is a positive finding.

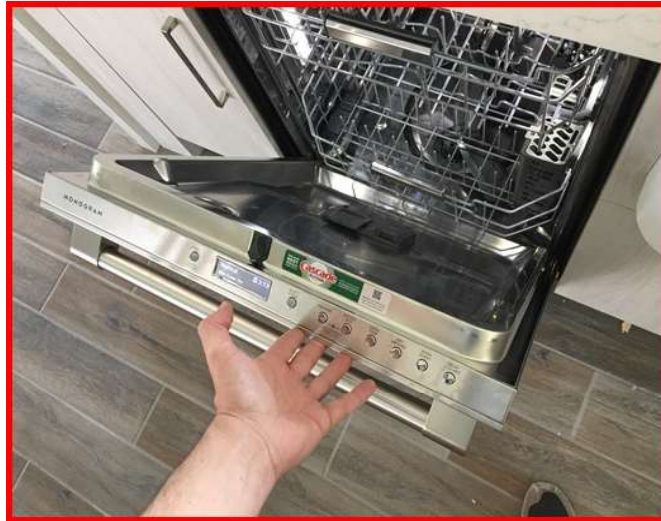
Photo 83-115(1):

83-115: Dishwasher maintenance and/or repairs needed. [F]

The dishwasher door has no spring tension and literally falls open, with force, because the door is heavy. Failure of a system or component. The system or component fails to operate or to operate properly. It is recommended this finding and all associated components be reviewed and corrected as needed by a licensed and qualified Appliance Repair Contractor.

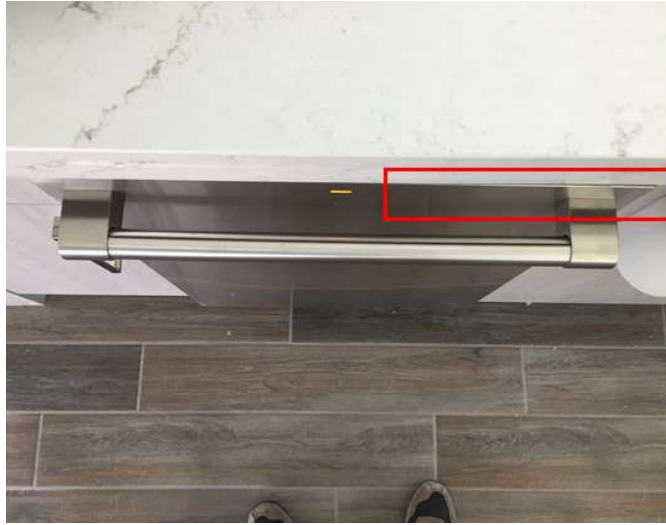
Photo 83-130(1):

83-130: Dishwasher faulty or otherwise amiss. [R] [N]

The dishwasher did not appear to be mounted square to the countertop. Discretion advised. The significance of the situation, problem or defect is uncertain. Further study is advised. It is recommended the builder or responsible prime contractor review this issue and correct as required in order to provide conformance with residential construction performance standards.

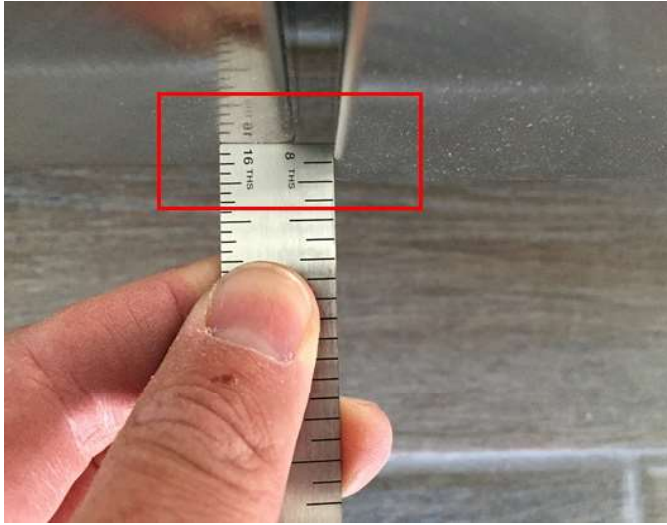
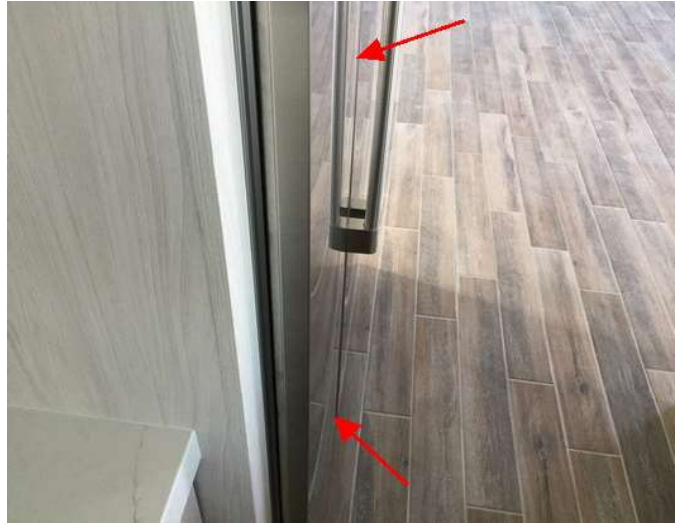
88-175: Refrigerator maintenance and/or repairs needed. [B] [R]

The doors did not appear properly adjusted. 1/8 inch displacement observed at the bottom portion of the doors. The installation does not appear to be in conformance with manufacturer's guidance or specifications. It is recommended the builder or responsible prime contractor review this issue and correct as required in order to provide conformance with residential construction performance standards.

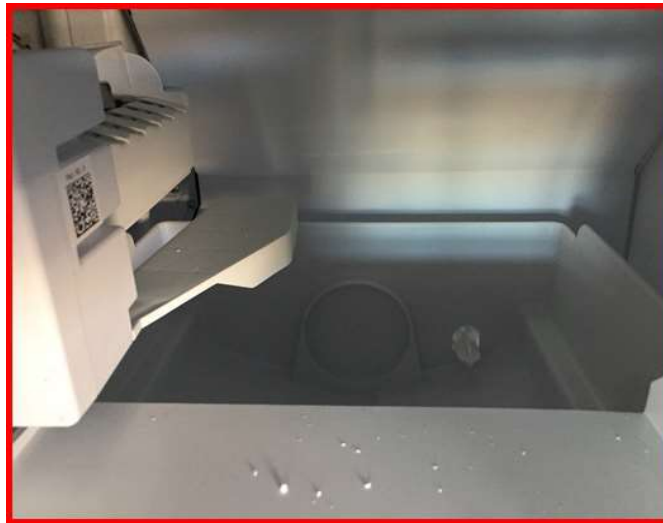
Photo 88-235(1):

88-235: Review of icemaker not provided. [R] [N]

KITCHEN: Icemaker appeared to be intentionally off. No ice was observed in the tray. Discretion advised. The significance of the situation, problem or defect is uncertain. Further study is advised. It is recommended the builder or responsible prime contractor review this issue and correct as required in order to provide conformance with residential construction performance standards.
