The Uniform Building Inspection Report

Single Family Residence:
[REDACTED]

Inspection Company:
INSPECT LV
7345 S. Durango Dr. #B107-159
Las Vegas, Nevada 89113
(702) 210-5333

Inspector:
Andrew Aliotti, CPI
IOS.0002659-RES

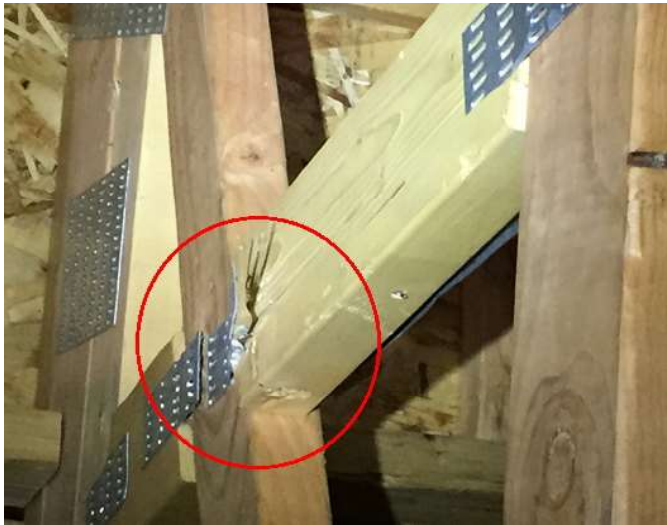
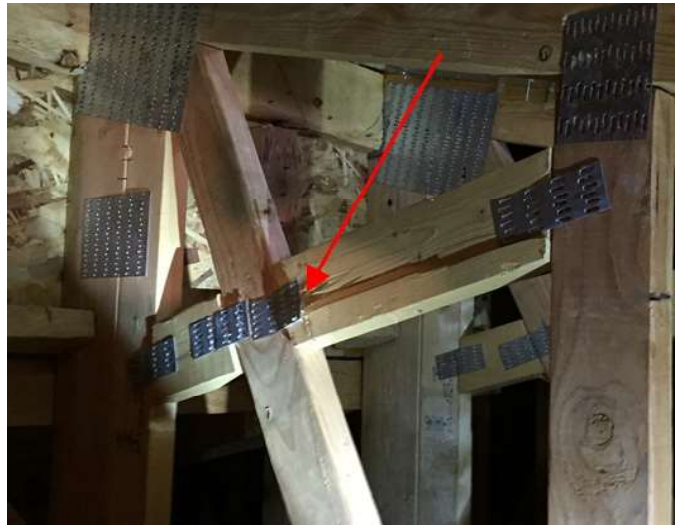
92-130: Framing member faulty or otherwise amiss. [R] [P] [B]

ATTIC: The factory setting allows for a high degree of quality control. Incorrectly manufactured trusses are quite rare, but not unheard of. For simple joints, the plate should be centered, although this isn't always true for larger joints with multiple members coming together. Misaligned plates are not as strong as the designer intended. You should always see a metal connector plate on both sides of a joint. Missing plates are almost always due to improper handling during construction, but if there are no marks in the wood, then the plate was never installed. The Truss Plate Institute (TPI) publication QST-88, Quality Standard For Metal Plate Connected Wood Trusses, says that the gap under a plate should not exceed 10 percent of the tooth length or 1/16," whichever is greater. It also says that such a gap should not exceed 1/3 of the plate contact area on each member in the joint. Repair is not as simple as hammering the plate back in because the fingers on the plate are designed to be pressed one time into undisturbed wood. The normal repair is to install a plywood or OSB gusset plate, nailed or screwed in place. These are usually much larger than the metal plate being replaced. It is recommended the builder or responsible prime contractor review this issue and correct as required in order to provide conformance with residential construction performance standards.

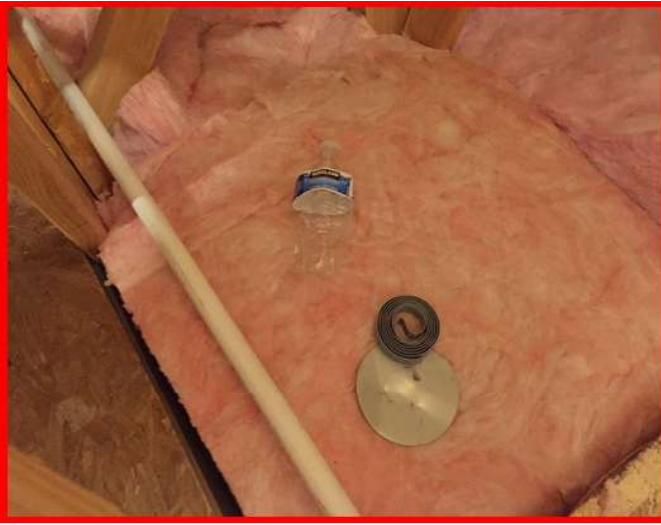
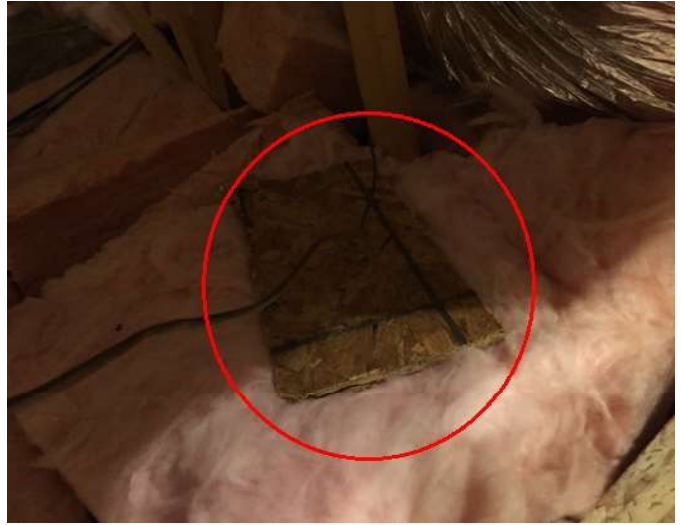
94-195: Debris present in attic. [B] [R]

Construction debris is noted to be left in the attic. This finding does not appear to conform to building standards and practices in effect at the time of construction or installation. It is recommended the builder or responsible prime contractor review this issue and correct as required in order to provide conformance with residential construction performance standards. The photographs depicted are only representative photographs of this finding.

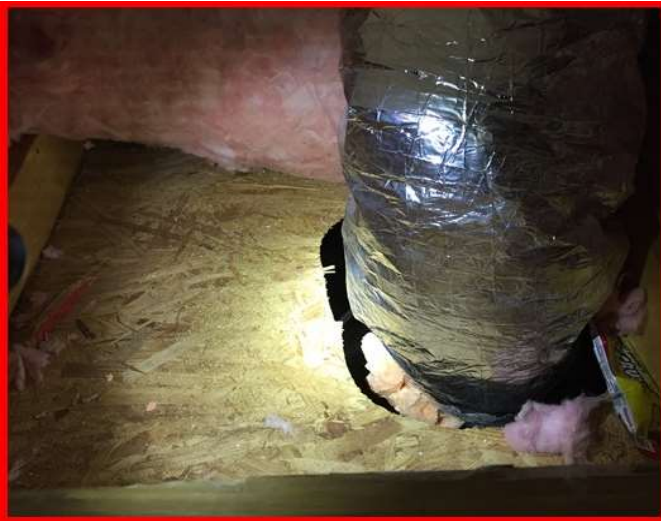
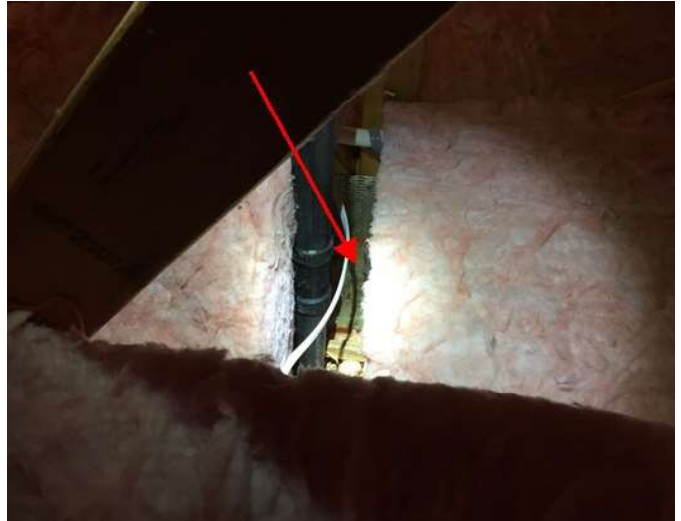
95-145: Insulation out of position. [E] [B]

ATTIC: Correction of this issue usually results in an increase of efficiency. This finding does not appear to conform to building standards and practices in effect at the time of construction or installation. It is recommended the builder or responsible prime contractor review this issue and correct as required in order to provide conformance with residential construction performance standards.
